Disaster Resistant University

Preliminary Seismic Screening of University of Nevada, Reno Campus August 2005

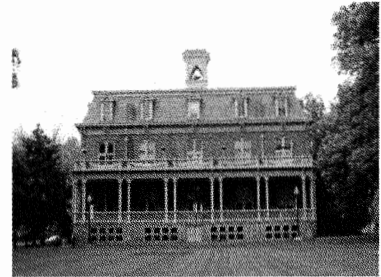
Morrill Hall Alumni Center (Final Score = 1.0): The Morrill Hall Alumni Center was occupied in 1886, prior to the adoption and enforcement of seismic codes. Its lateral system is un-reinforced masonry, which has a basic score of 1.8. Morrill Hall has a final score of 1.0, based on the basic score and modifications. Morrill Hall had minor connection upgrades between the floor and wall installed during its remodel, but the upgrades, as shown on the drawings available, do not appear to be sufficient for adjusting its score.
