**DEPARTMENT OF CORRECTIONS – CARLIN CONSERVATION CAMP AND JEAN CONSERVATION CAMP**

Pursuant to NRS 209.136 Nevada Department of Corrections notification for the permanent closures of the Carlin Conservation Camp and Jean Conservation Camp due to the costs to bring the camps up to structural and correctional standards.

Site Number: 9892  
STATE OF NEVADA PUBLIC WORKS DIVISION  
FACILITY CONDITION ANALYSIS

## SPWD Facility Condition Analysis

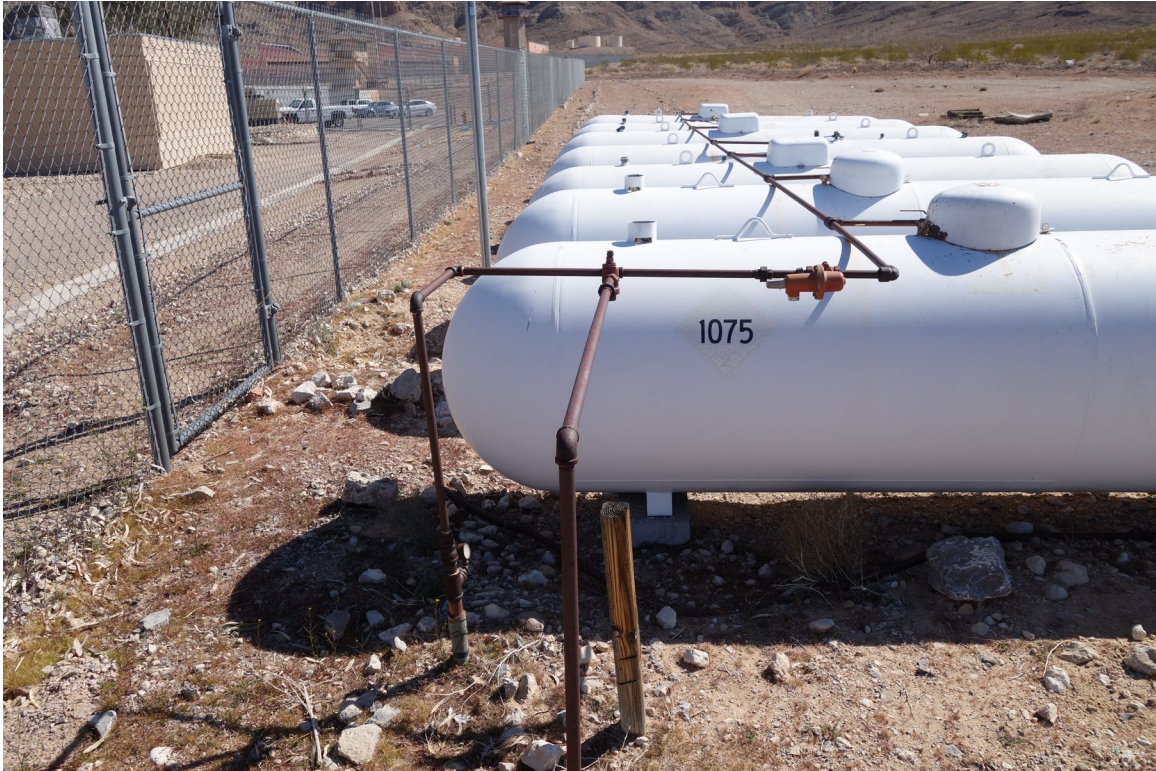
Jean Conservation Camp Site – FCA Site #9892  
Description: Seismic Shut-Off Valve for Site Needed.

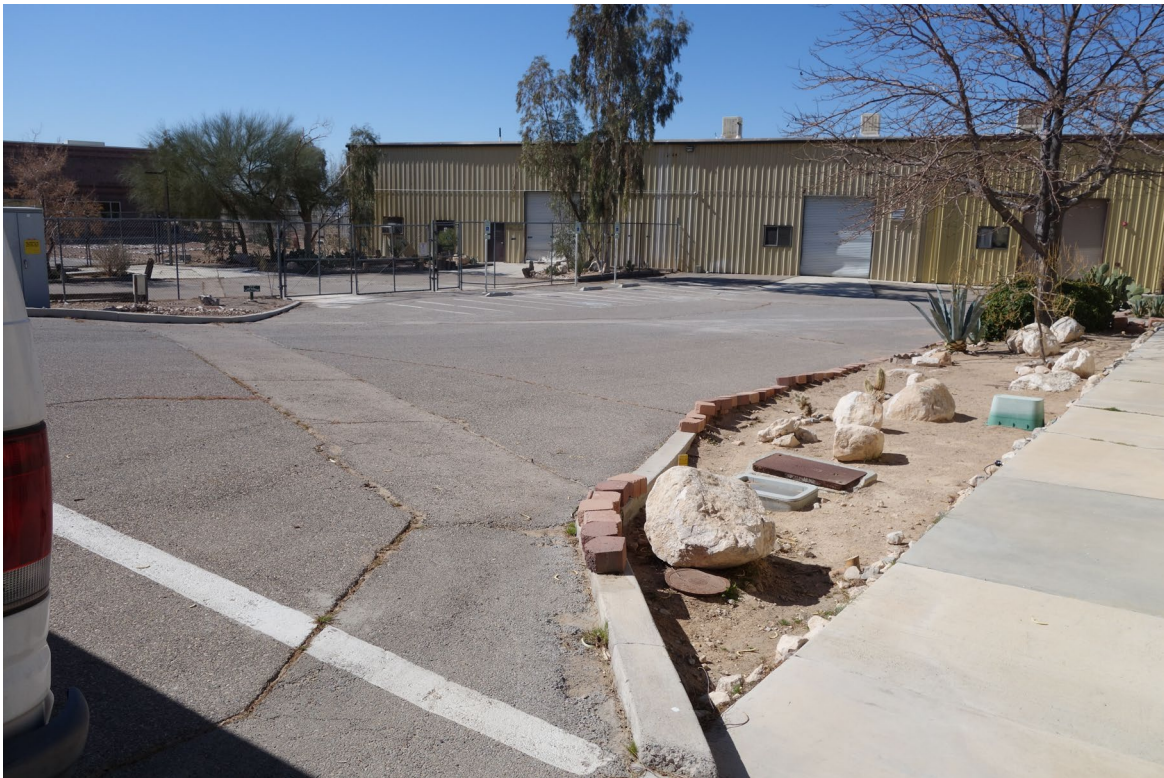
There are several areas where alligator cracking is beginning to become prevalent and where patching is needed before further degradation and potholing occur. The cracks throughout the paved areas need to be sealed to keep water infiltration from causing additional failures and the traffic surface is due for cyclical maintenance. This project will perform patching, crack sealing and surface sealing of the paved areas. 50,000 square feet was used for this estimate.

Jean Conservation Camp Site – FCA Site #9892  
Description: Crack Patch & Slurry Seal Needed.

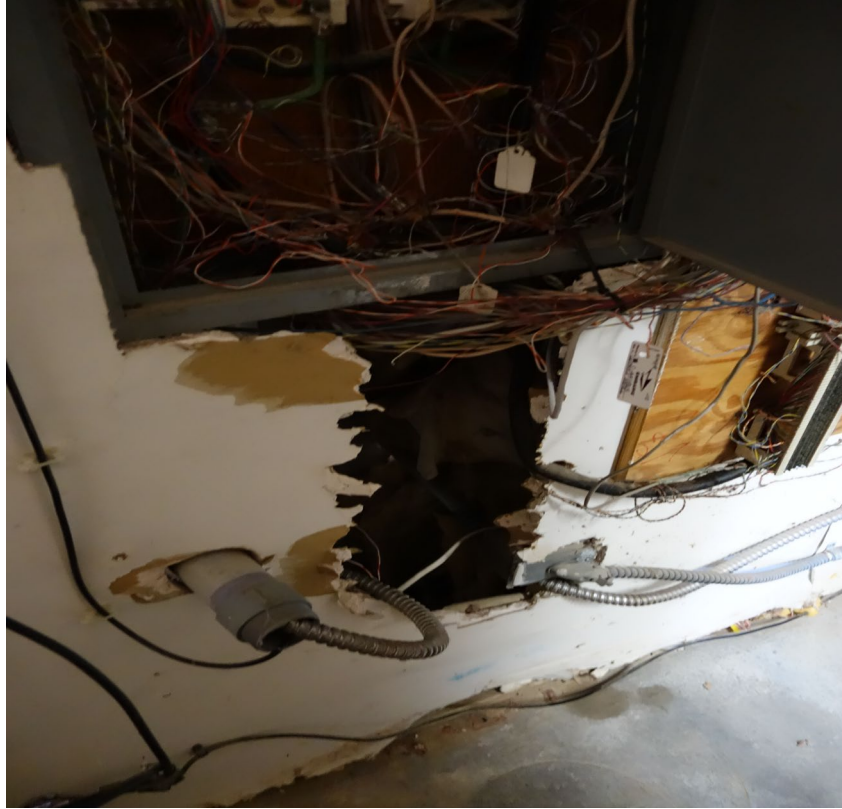
Jean CC NDF Office – FCA Building #2494  
Description: Wiring Cleanup & Wall Repair Needed.

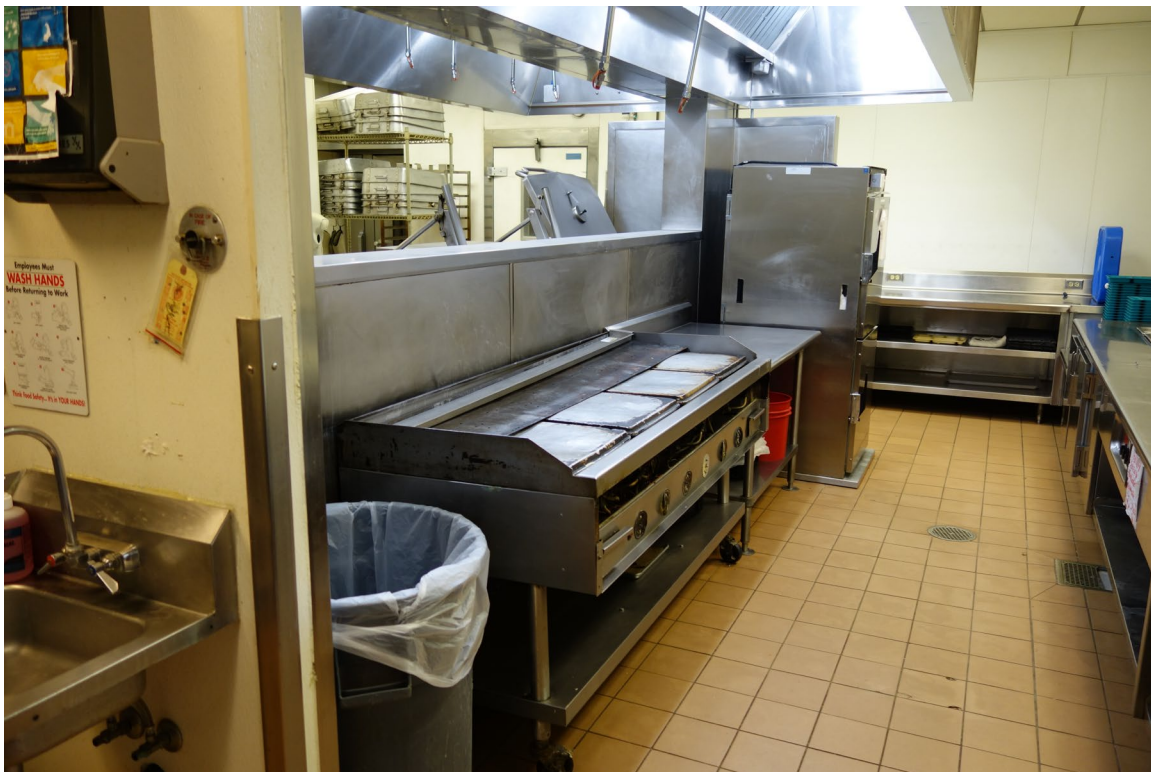
Culinary / Canteen / Dining Hall – FCA Building #2125  
Description: Inoperable Culinary Equipment Replacement Needed.

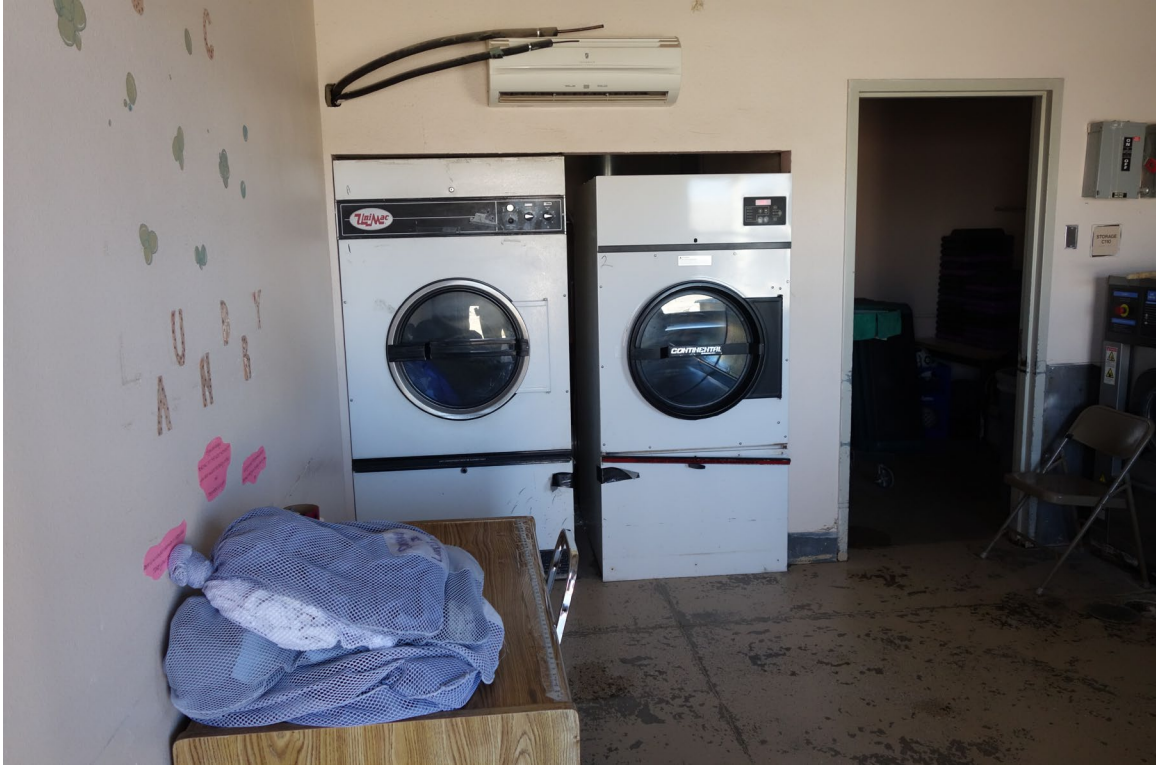
Culinary / Canteen / Dining Hall – FCA Building #2125  
Description: Floor Coating Replacement Needed.

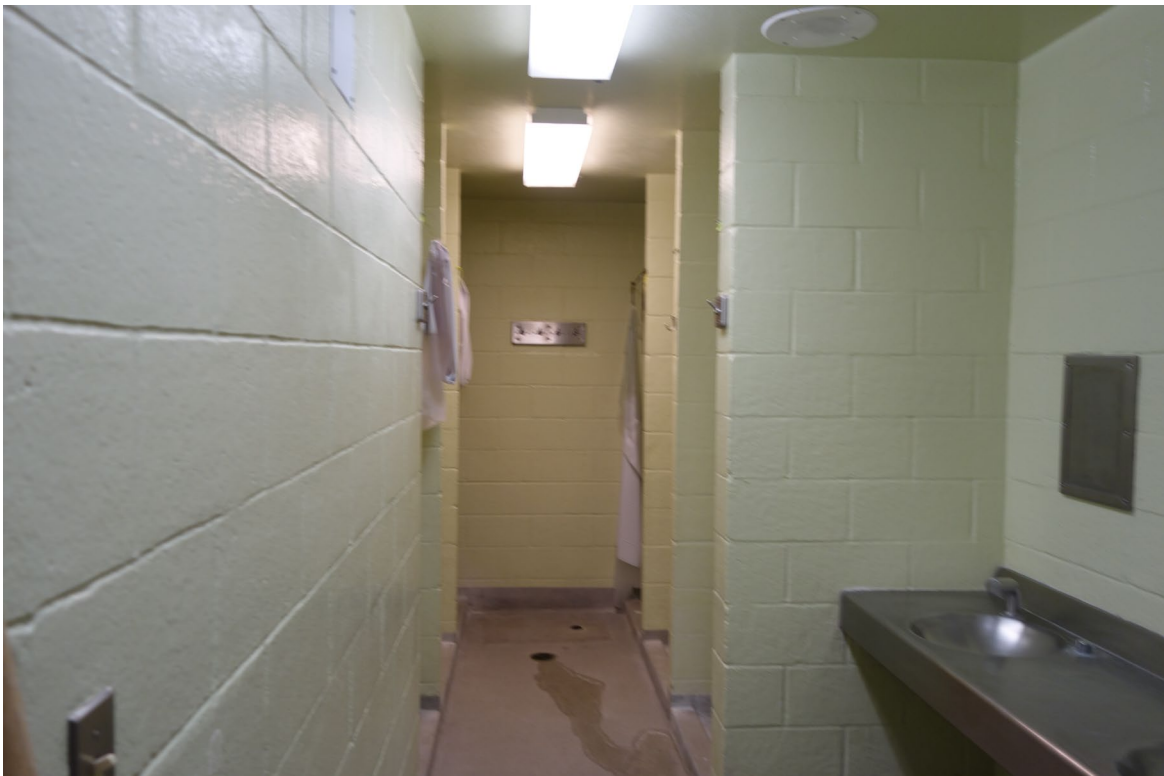
Housing Unit 4 – FCA Building #1986  
Description: Shower & Underground Plumbing Replacement Needed.

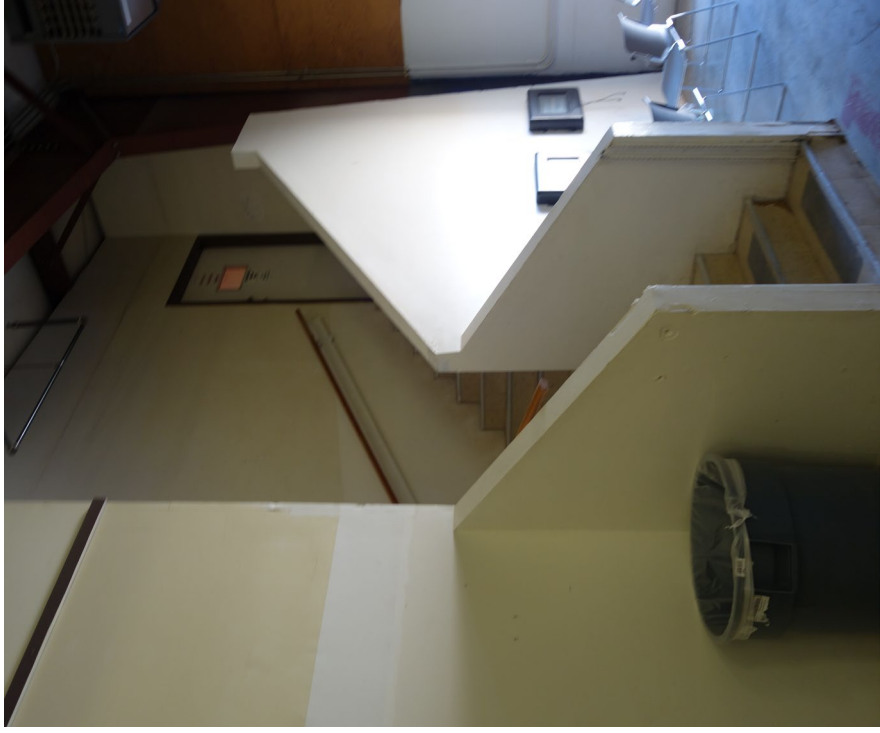
MPR / Visitation / NDF Shop – FCA Building #1898

Description: Stair Replacement Recommended.

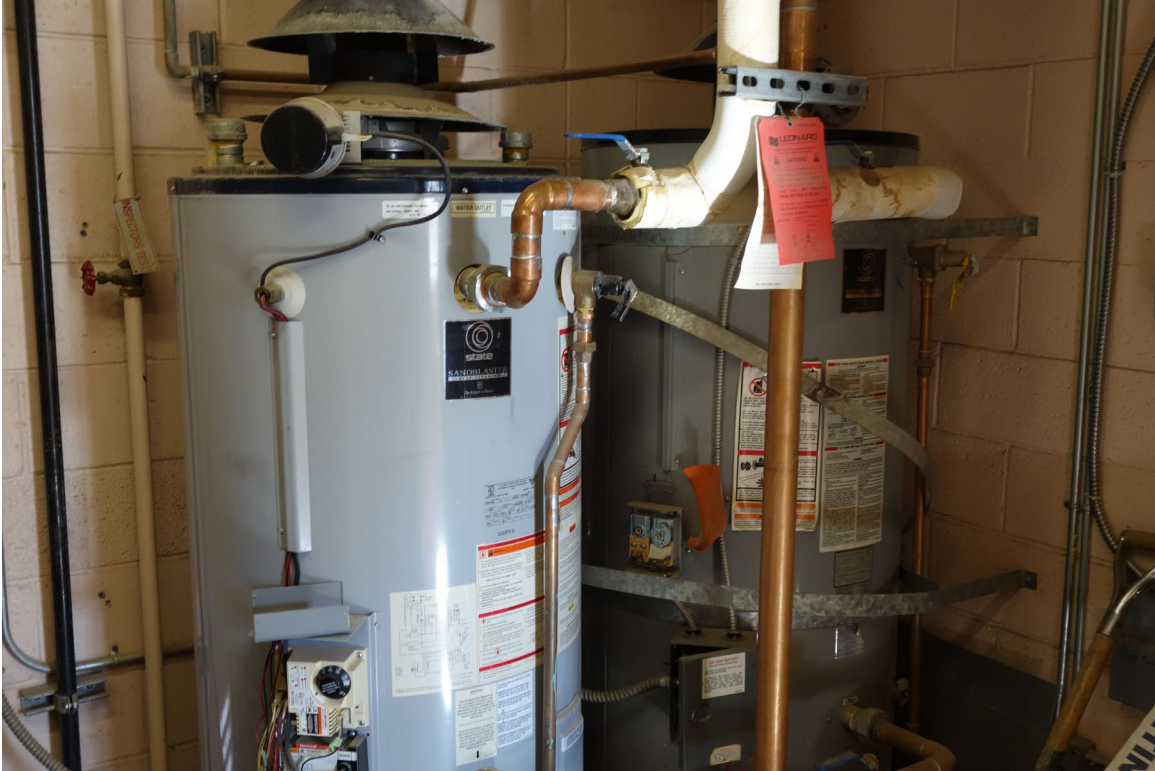
Housing Unit 3 – FCA Building #1897  
Description: Water Heater Replacement Recommended.

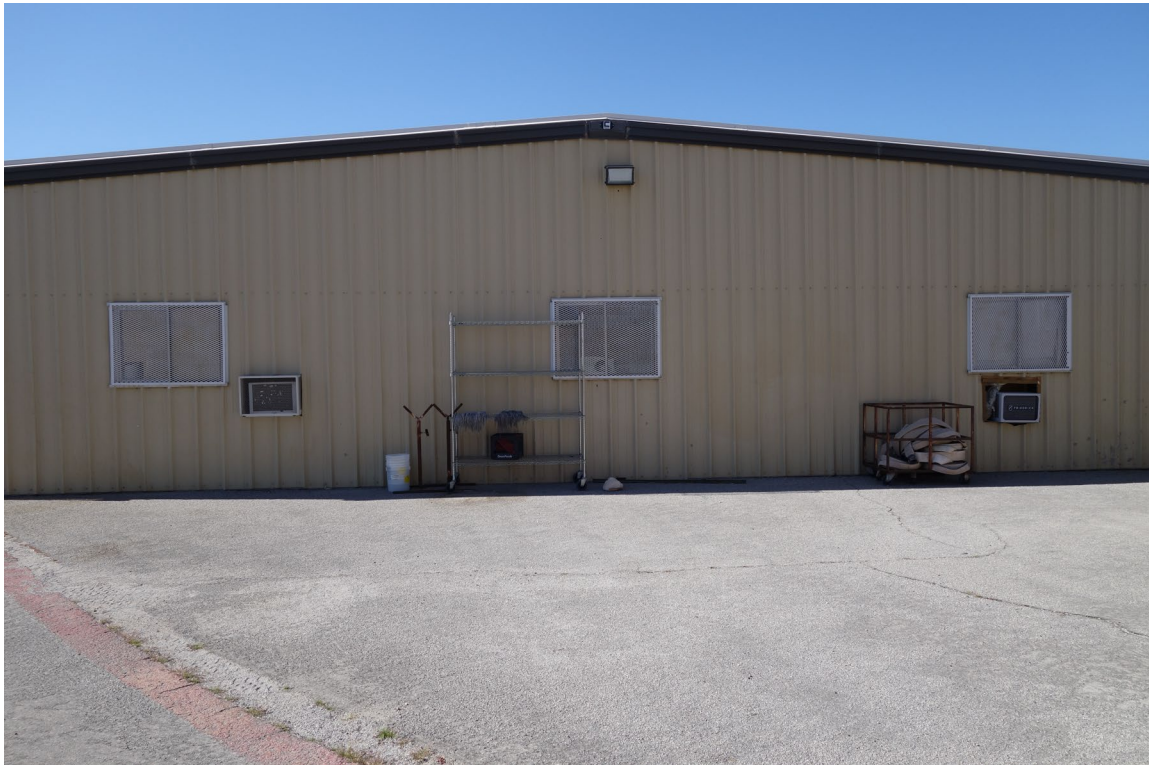
Administration Office / Medical – FCA Building #0663  
Description: HVAC Upgrade / Replacement Needed.

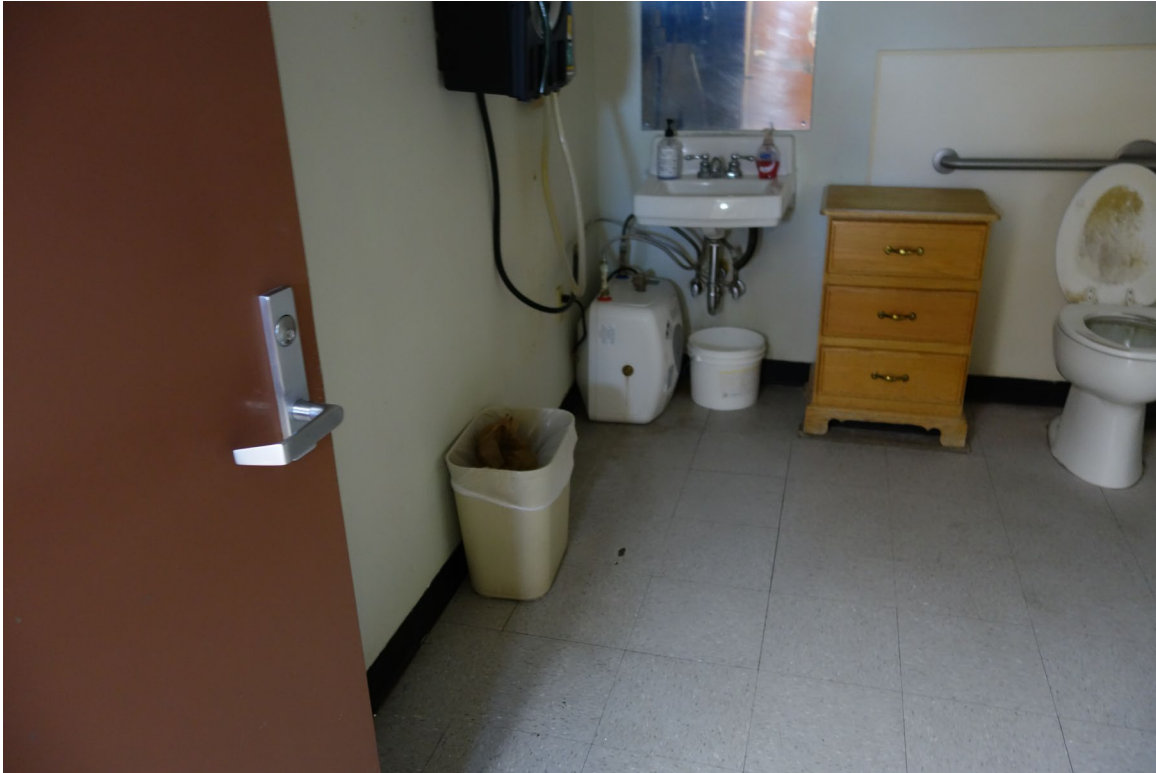
Administration Office / Medical – FCA Building #0663  
Description: ADA Restroom Upgrades Needed.

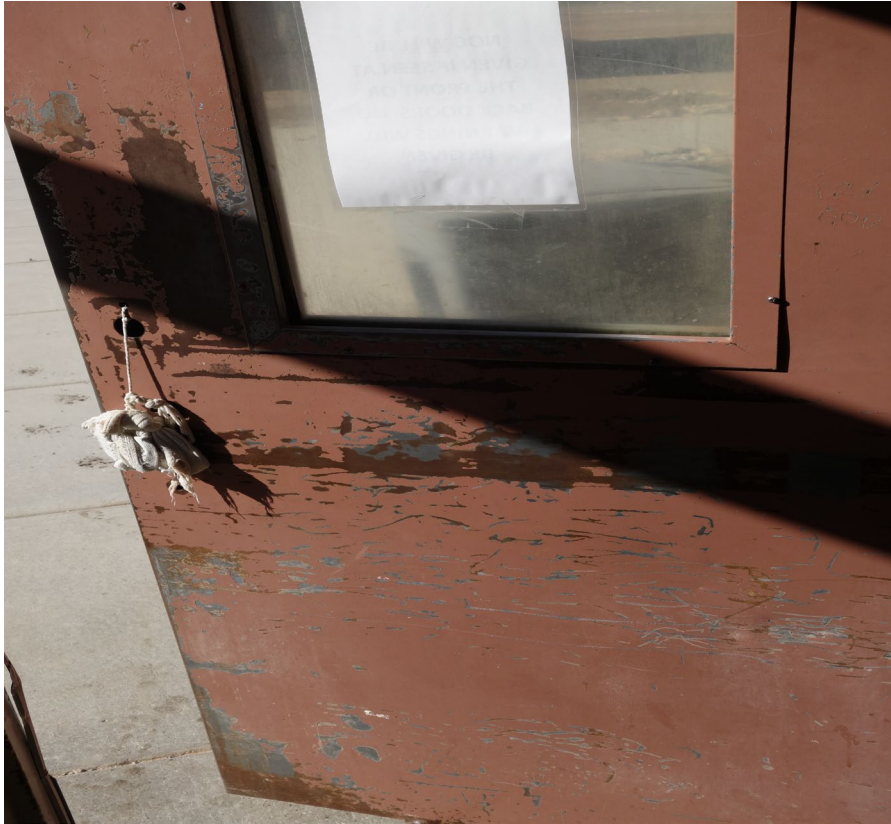
Housing Unit 2 – FCA Building #0662  
Description: Exterior Door & Hardware Replacement Needed.

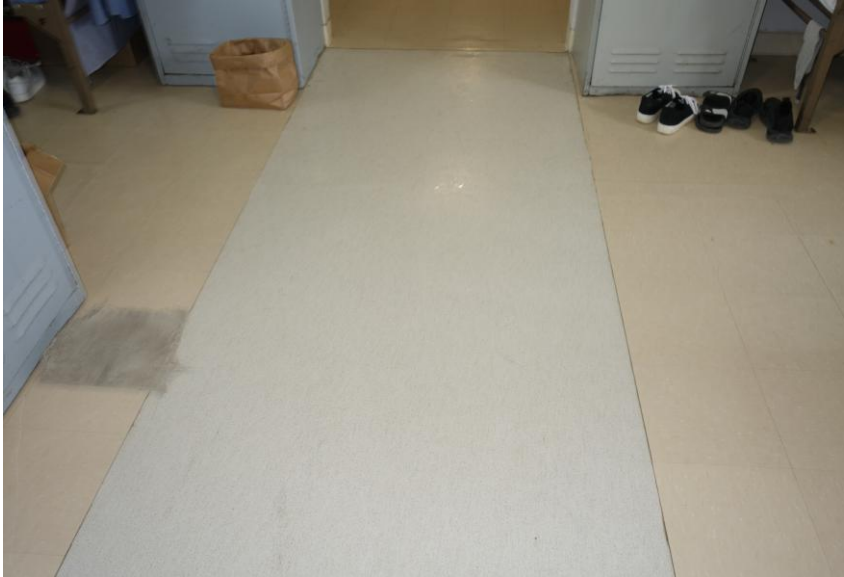
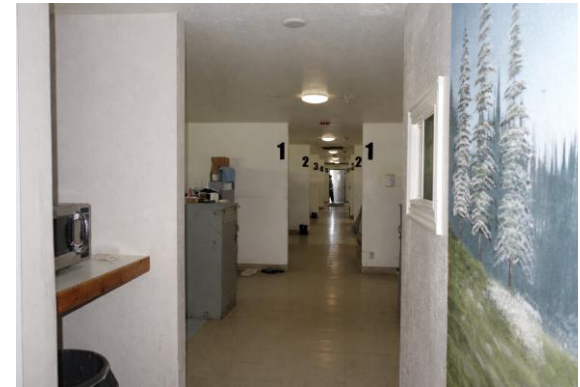
### REINSTATED BUILDING INTERIOR - 11/18/2025 0697-INT-1: REPLACE FLOORING

The vinyl composite tile (VCT) in the building are damaged and nearing the end of their useful life. It is recommended that the VCT be replaced. This project will fund the removal and disposal of the existing flooring and the installation of new 12" x 12" VCT with a 4" base within the next 2 - 3 years. Any costs related to Asbestos Containing Materials (ACM) testing or abatement are not included in this project.

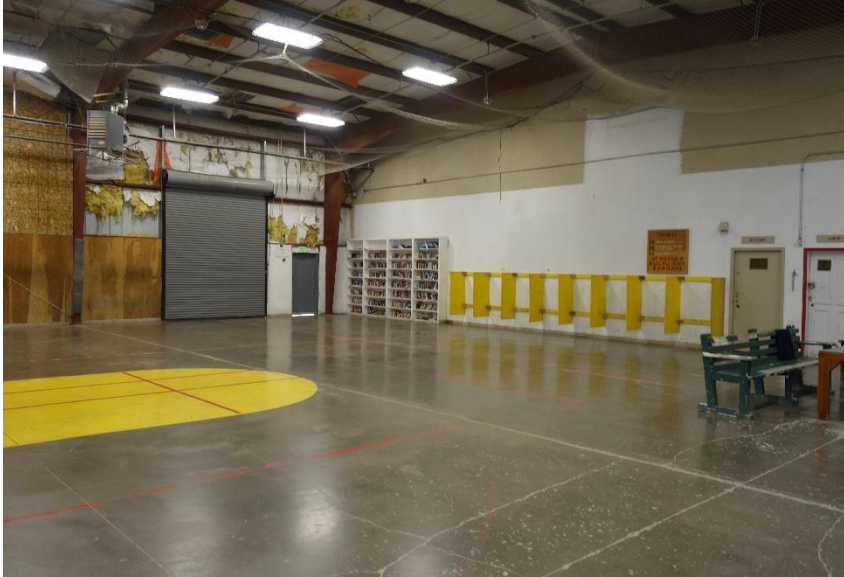
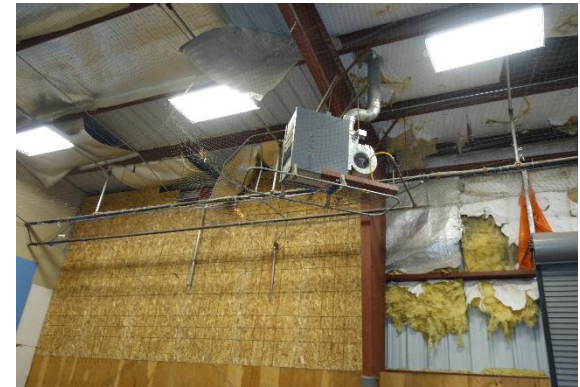
### NEW BUILDING INTERIOR - 11/19/2025 1580-INT-3: REPLACE INSULATION

There are multiple areas throughout the ceiling where insulation is damaged or missing, compromising the building's energy efficiency and thermal performance. To address this, the project proposes the removal of the existing ceiling insulation and the installation of new faced R-38 insulation. This upgrade will enhance thermal resistance, improve occupant comfort, and contribute to reduced energy costs by increasing the building's overall insulation performance.

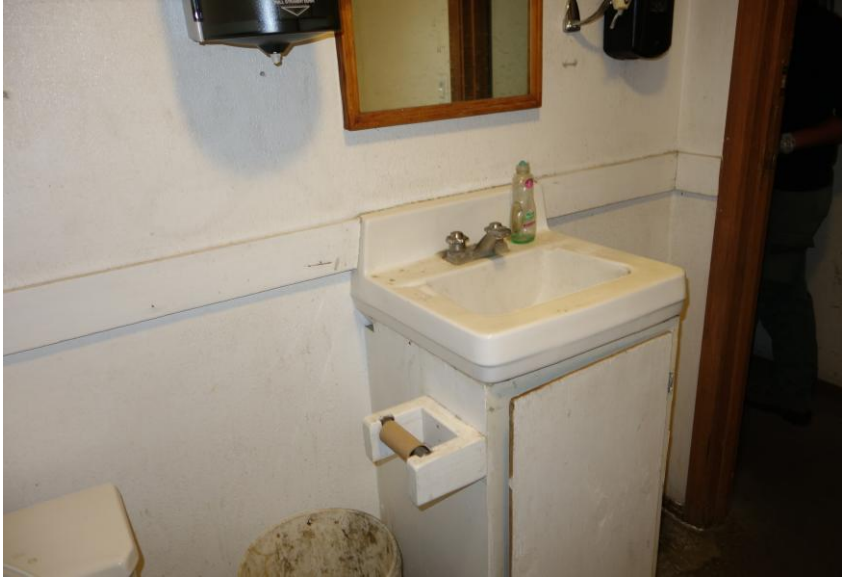
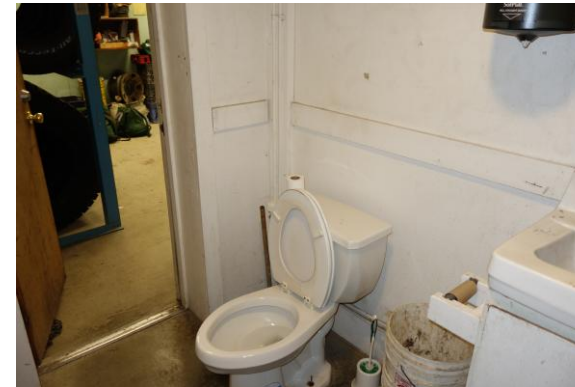
## NEW BUILDING INTERIOR - 11/20/2025 2156-INT-2: RESTROOM UPGRADE

The restroom in the building is original, in poor condition, and lack compliance with ADA accessibility standards—specifically, at least one restroom per floor must meet current requirements. This project includes funding for the complete refurbishment of the restroom. As part of the renovation, the restroom will be upgraded to meet ADA standards. Scope of work may include wall reconfiguration, installation of new sinks, toilets, hardware, mirrors, fixtures, flooring, finishes and signage. Design and compliance will be guided by the 2024 International Building Code (IBC), ICC A117.1, NRS

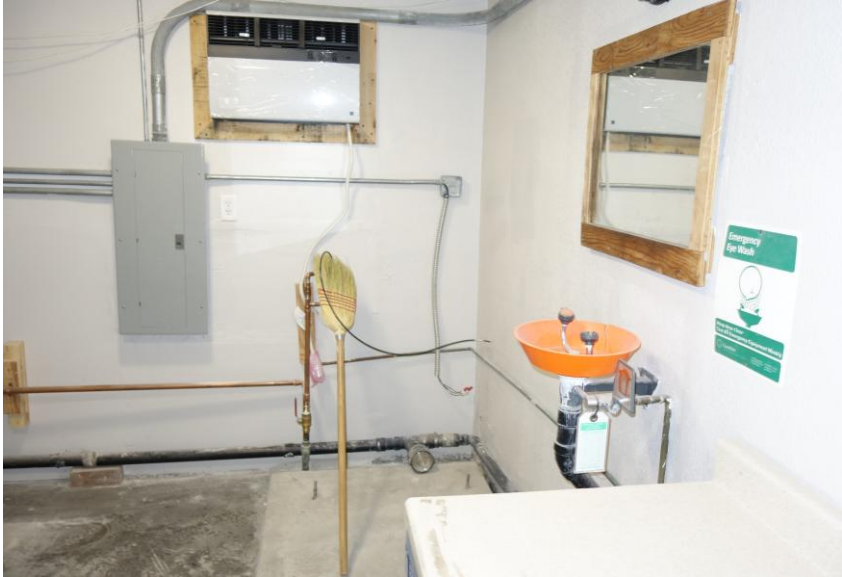
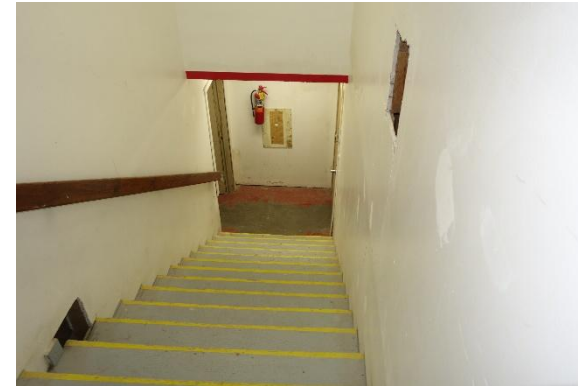
### IN PROGRESS BUILDING INTERIOR - 11/19/2025 1580-INT-2: INTERIOR FINISHES

The interior finishes are in fair condition. It is recommended that the interior walls and ceilings be painted at least once in the next two to three years and every 2 - 4 years thereafter to maintain the integrity of the interior of the building. Prior to painting, all surfaces should be repaired and prepped. An epoxy-based paint should be utilized in wet areas for durability.

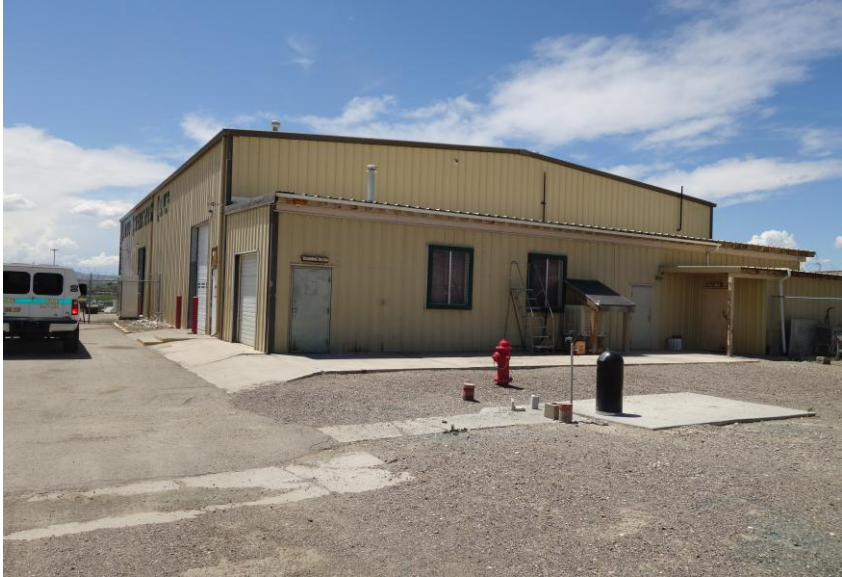
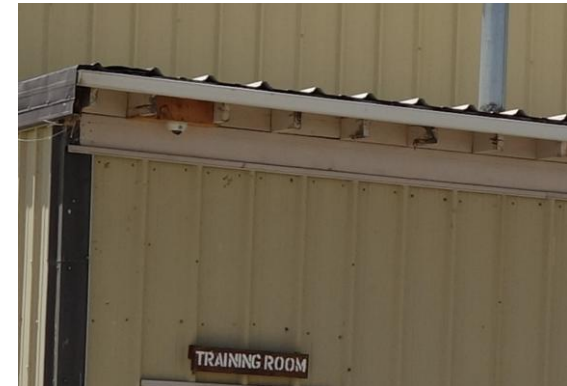
### REINSTATED BUILDING EXTERIOR - 11/19/2025 2155-EXT-1: EXTERIOR FINISHES

The exterior finishes were in poor condition. It is important to maintain the finish, weather resistance and appearance of the building. This project recommends work to protect the exterior building envelope, other than the roof, including painting, staining, or other applied finishes, and caulking around windows, flashing, fixtures, and other penetrations to maintain the building in good, weather tight condition. It is recommended that this project be implemented in the next 2 - 4 years and is recommended on a cyclical basis based on environmental conditions.

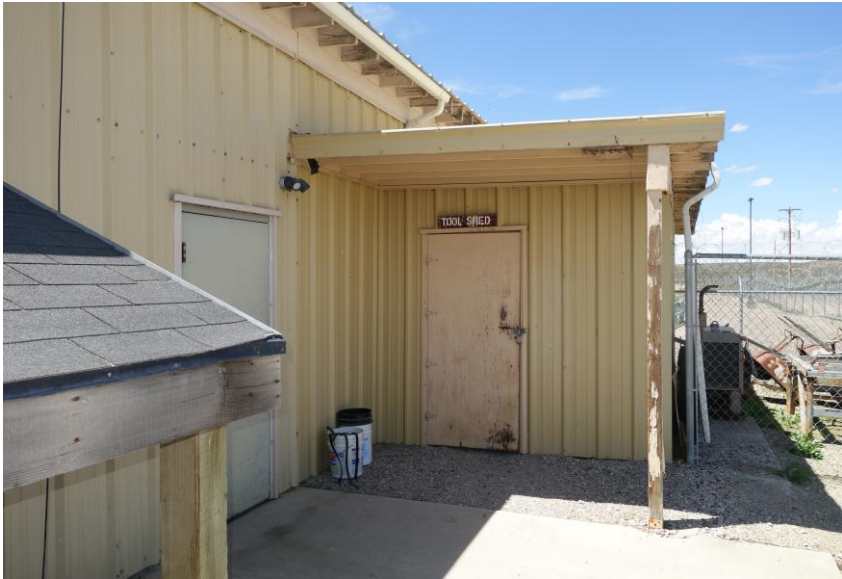
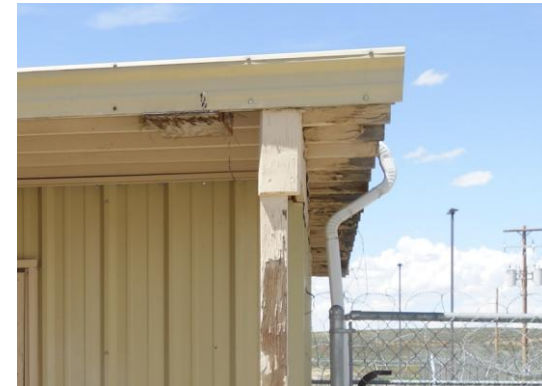
### REINSTATED BUILDING EXTERIOR - 11/17/2025 2154-EXT-1: EXTERIOR FINISHES

The exterior finishes were in poor condition. It is important to maintain the finish, weather resistance and appearance of the building. This project recommends work to protect the exterior building envelope, other than the roof, including painting, staining, or other applied finishes, and caulking around windows, flashing, fixtures, and other penetrations to maintain the building in good, weather tight condition. It is recommended that this project be implemented in the next 2 - 4 years and is recommended on a cyclical basis based on environmental conditions.

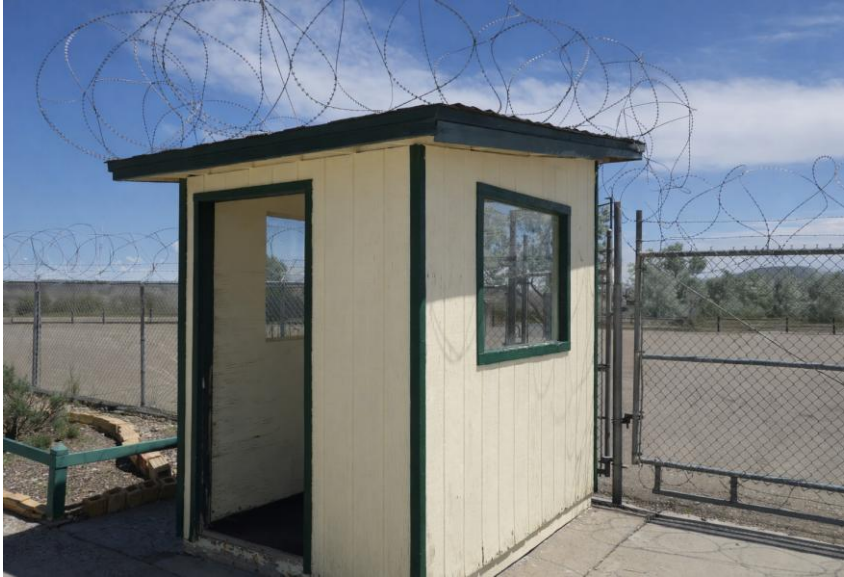
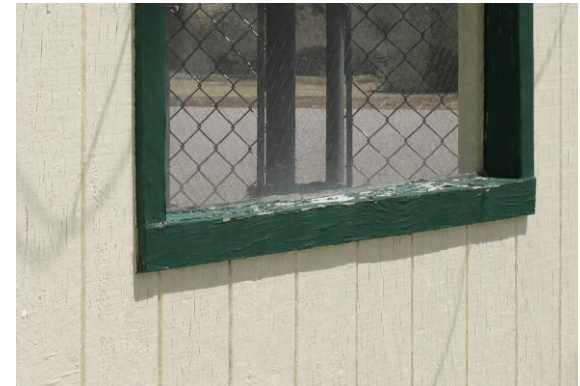
### REINSTATED BUILDING EXTERIOR - 11/14/2025 2145-EXT-2: EXTERIOR FINISHES

The exterior finishes were in poor condition. It is important to maintain the finish, weather resistance and appearance of the building. This project recommends work to protect the exterior building envelope, other than the roof, including painting, staining, or other applied finishes, and caulking around windows, flashing, fixtures, and other penetrations to maintain the building in good, weather tight condition. It is recommended that this project be implemented in the next 2 - 3 years and is recommended on a cyclical basis based on environmental conditions.

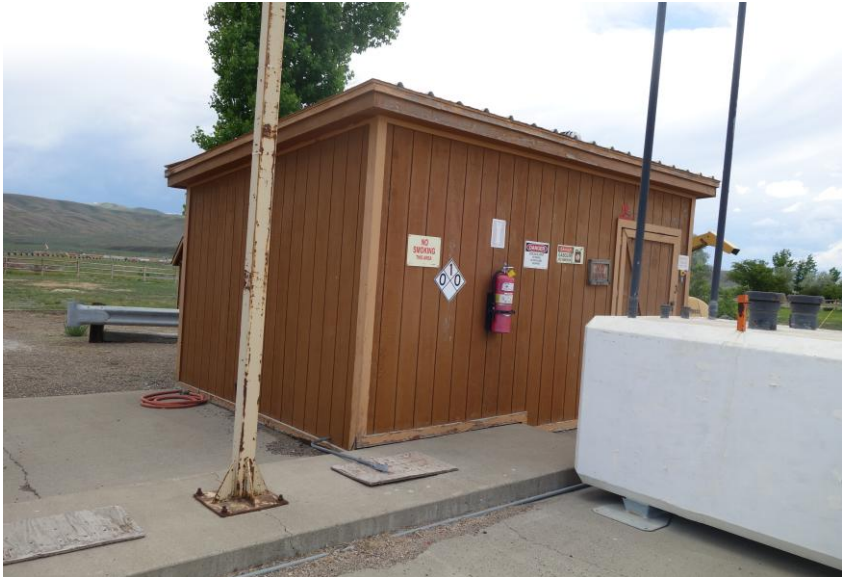
### NEW BUILDING EXTERIOR - 11/18/2025 4309-EXT-1: EXTERIOR FINISHES

The exterior finishes of the building are in poor condition, and maintaining the building's finish, weather resistance, and appearance is essential. This project will fund improvements to protect the exterior envelope of the building, excluding the roof. The scope includes painting, staining, or sealing the exterior walls, along with caulking around windows, flashing, fixtures, and all other exterior penetrations. It is recommended that this work be completed within the next 2 - 4 years and scheduled on a recurring

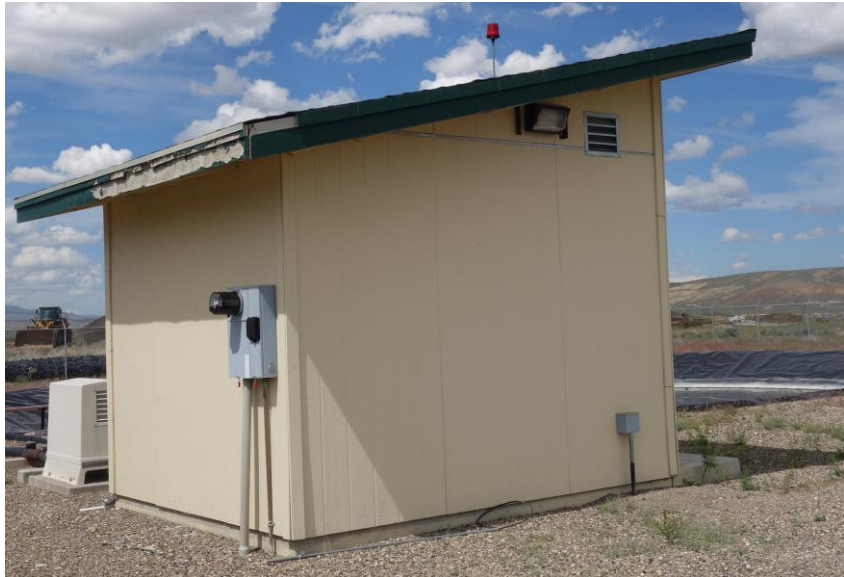
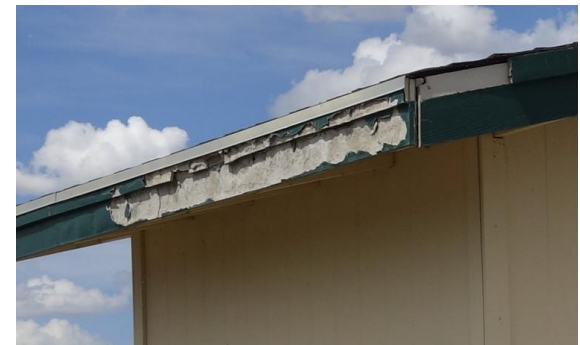
### NEW BUILDING EXTERIOR - 11/20/2025 3162-EXT-1: EXTERIOR FINISHES

The exterior finishes of the building are in poor condition, and maintaining the building's finish, weather resistance, and appearance is essential. This project will fund improvements to protect the exterior envelope of the building, excluding the roof. The scope includes painting, staining, or sealing the exterior walls, along with caulking around windows, flashing, fixtures, and all other exterior penetrations. It is recommended that this work be completed within the next 2 - 4 years and scheduled on a recurring

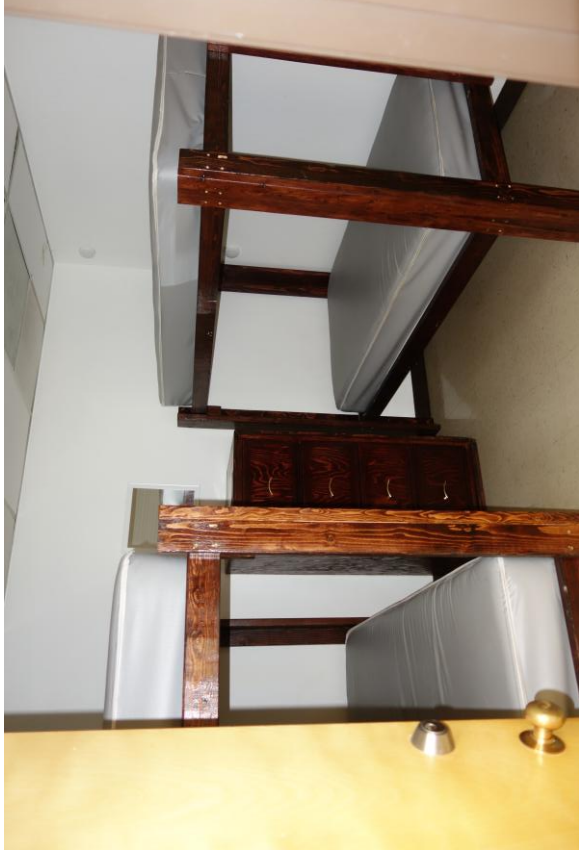
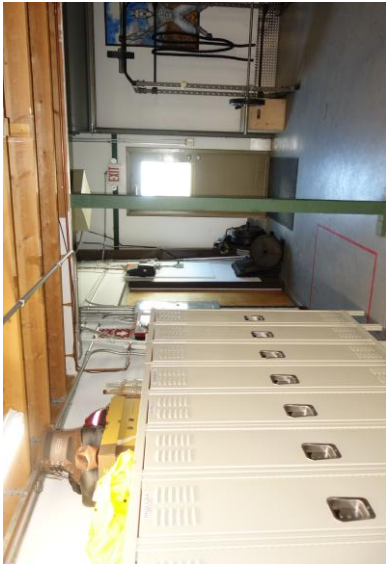
NEW BUILDING INTERIOR - 11/19/2025  
1581-INT-2: INTERIOR FINISHES

The interior finishes are in good condition. It is recommended that the interior walls and ceilings be repainted within the next 6 - 8 years. Prior to painting, all surfaces should be properly repaired and prepared to ensure a durable and uniform finish. In wet or high humidity areas, the use of an epoxy-based paint is recommended to enhance moisture resistance and durability. To preserve the quality of interior finishes and support the longevity of the structure, ongoing building maintenance should be scheduled on a regular, cyclical basis.

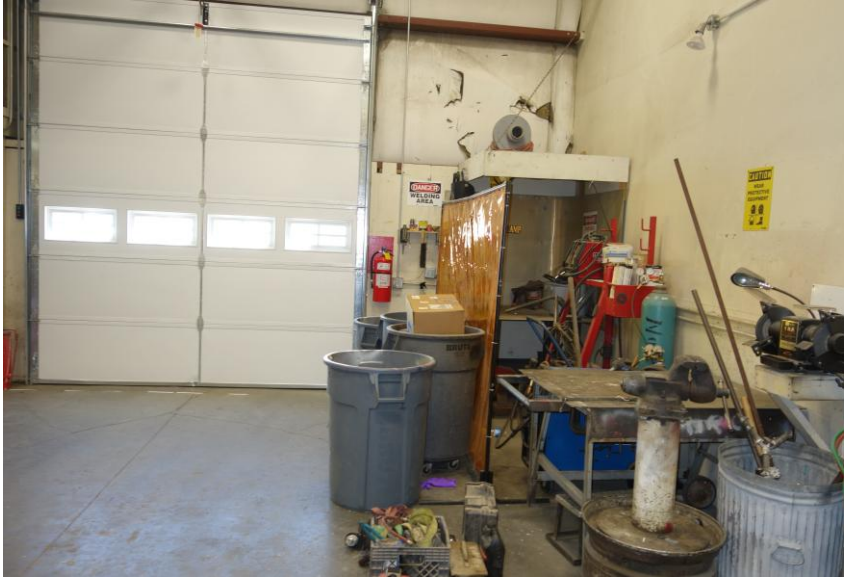
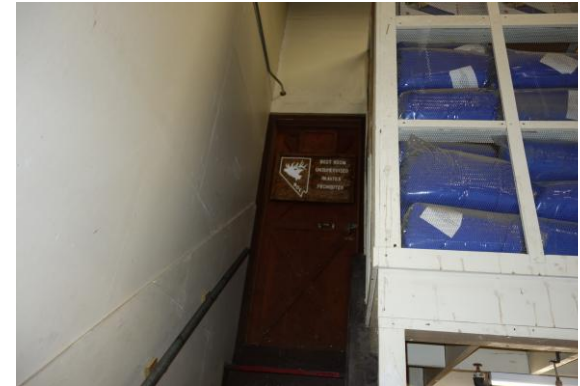
## REINSTATED BUILDING INTERIOR - 11/20/2025 2156-INT-1: INTERIOR FINISHES

The interior finishes are in fair condition for an industrial shop. It is recommended that the interior walls be painted at least once in the next 8 - 10 years. Prior to painting, all surfaces should be repaired and prepped. An epoxy-based paint should be utilized in wet areas for durability.

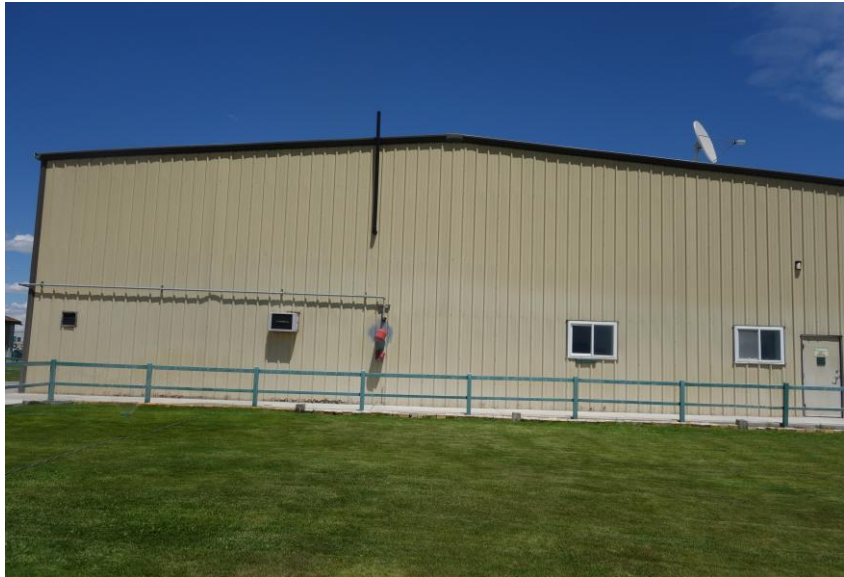
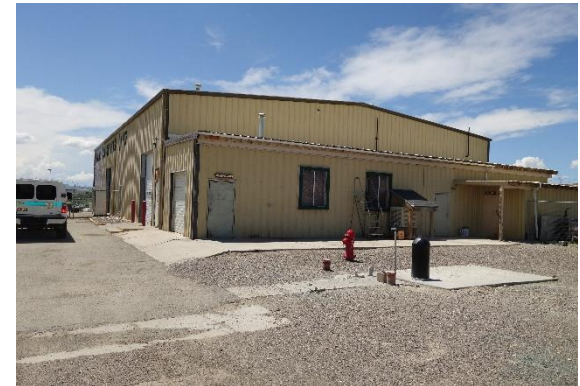
### REINSTATED BUILDING EXTERIOR - 11/20/2025 1580-EXT-2: EXTERIOR FINISHES

It is important to maintain the finish, weather resistance and appearance of the building. This project recommends work to protect the exterior building envelope, other than the roof, including metal siding repairs, or other applied finishes, and caulking around windows, flashing, fixtures, and other penetrations to maintain the building in good, weather tight condition. It is recommended that this project be implemented in the next 4 - 5 years and is recommended on a cyclical basis based on environmental conditions.

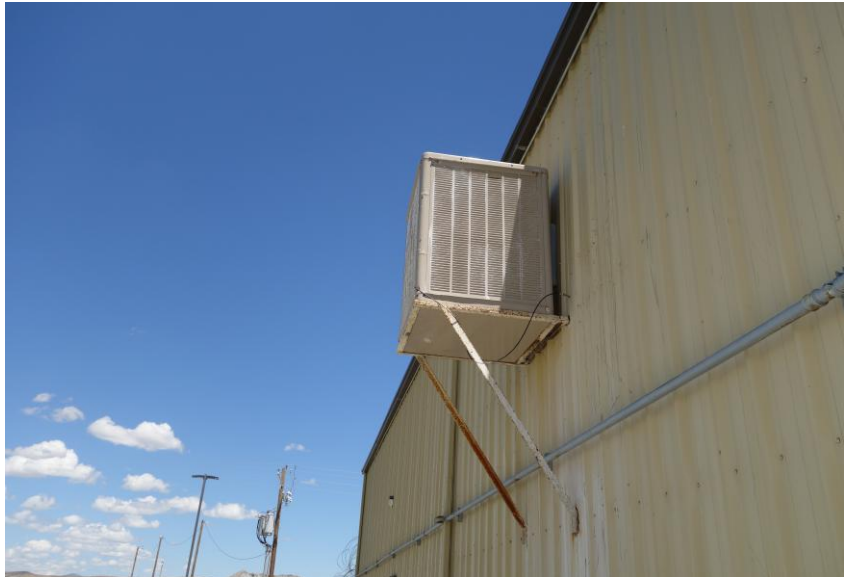
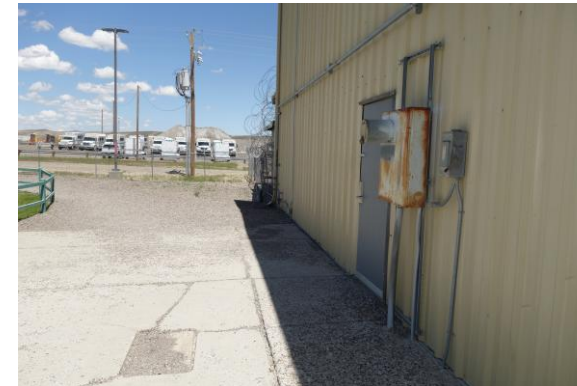
### REINSTATED BUILDING EXTERIOR - 11/20/2025 2156-EXT-1: EXTERIOR FINISHES

The exterior finishes were in fair condition. It is important to maintain the finish, weather resistance and appearance of the building. This project recommends work to protect the exterior building envelope, other than the roof, including painting, staining, or other applied finishes, and caulking around windows, flashing, fixtures, and other penetrations to maintain the building in good, weather tight condition. It is recommended that this project be implemented in the next 4 - 5 years and is recommended on a cyclical basis based on environmental conditions.
