Preservation, Development and Use of the Nevada State Prison

Nevada State Prison Steering Committee

September 2014

Inventory of Existing Conditions

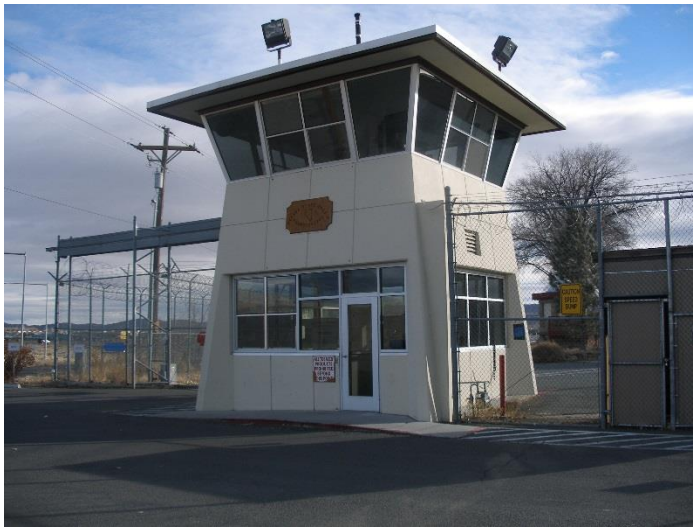
- The Main Gate / Tower 1 is located on the west side of the prison and next to a vehicle gate.
- This building is in generally fair shape.
- The building is a painted precast concrete structure that has two levels.
- It has approximately 450 square feet of space and was constructed in 1963.
- The lower level served as the visitor's check in and entry point into the prison.
- The upper level is the guard tower.

- The interior wall, floor and ceiling finishes are in poor condition.
- The interior finishes are faded and damaged to a point where the concrete walls and floors are showing wear and deterioration.

- The building's sanitary wastewater system is showing signs of deterioration.
- The drains operate slowly.
- Deposits within the pipes will cause them to be restricted, which will slow the flow of water.

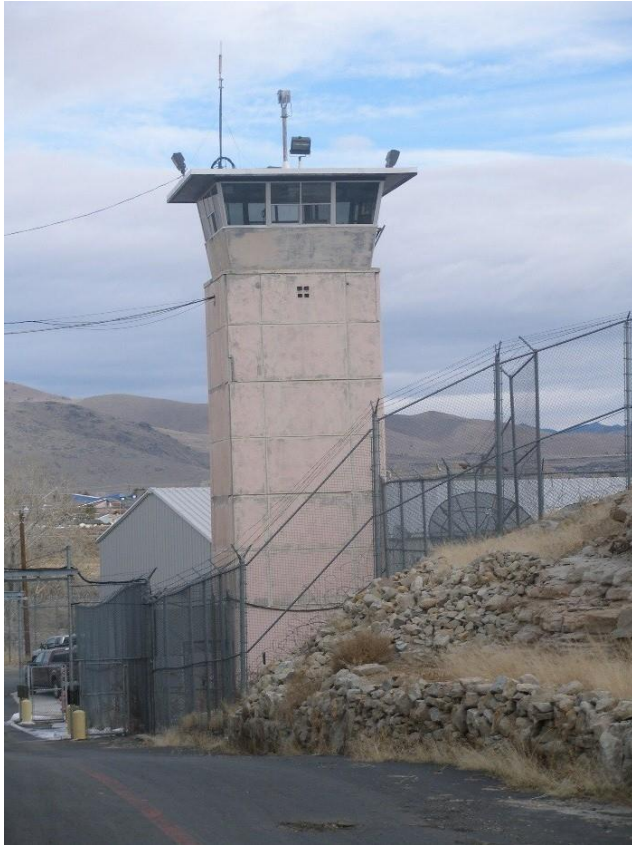
Guard Tower 2

- Guard Tower #2 is a painted precast concrete structure with a single-ply membrane roof.
- The tower is located inside of the secured area in the northeast corner of the site.
- It is three stories tall and has a 360 degree view of the prison grounds.
- It has 624 square feet of usable interior space which is accessed via a tall, winding, and intimidating staircase/ladder system.
- The tower is in fair condition.

- The roofing system was replaced in 2004.
- It would on require exterior maintenance for the representation of a prison security post.

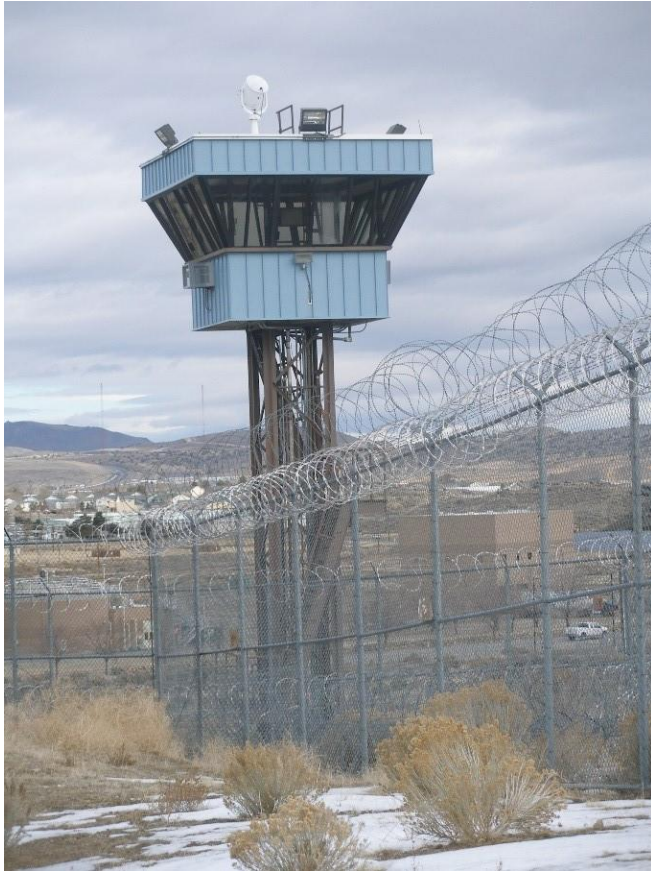
Guard Towers 3 & 4

- Guard Towers 3 and 4 are painted structural steel buildings with metal siding and roofs.
- They are located outside of the secured area in the northeast and southeast corners of the site.
- They were constructed in 1981, to serve as perimeter security for the "hill units".
- The interiors allow for a 360 degree view of the prison grounds.
- The buildings are in fair shape though there are concerns regarding their structures.

- There is no projected use presented for these structures.
- Recommend be maintained in arrested decay.

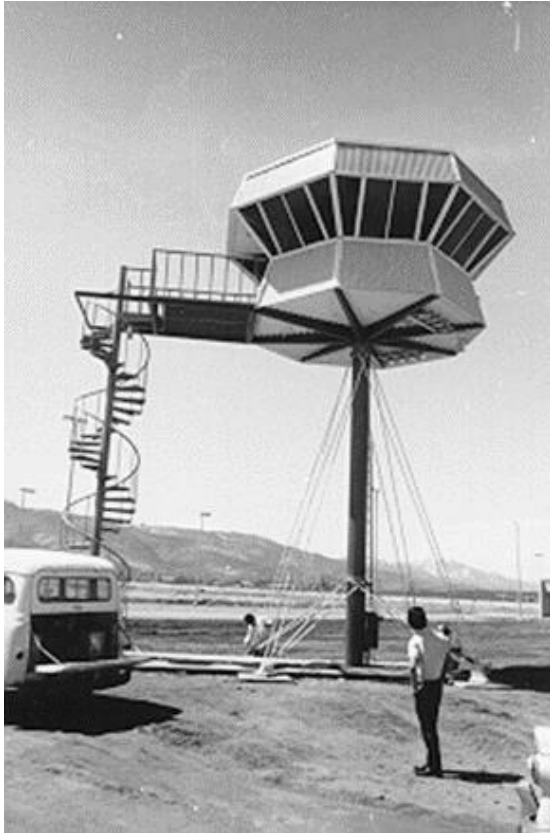
Tower 5

- Guard Tower #5 is a painted structural steel building (Space Needle) with metal siding and roof accessed by a steel spiral stairway.
- The tower is located outside of the secured area in the southwest corner of the site.
- The structure was constructed in 1966.
- There are windows that allow for a 360 degree view of the prison grounds.
- The building is in fair shape.

- There is no projected use presented for this structure.
- Recommend be maintained in arrested decay.

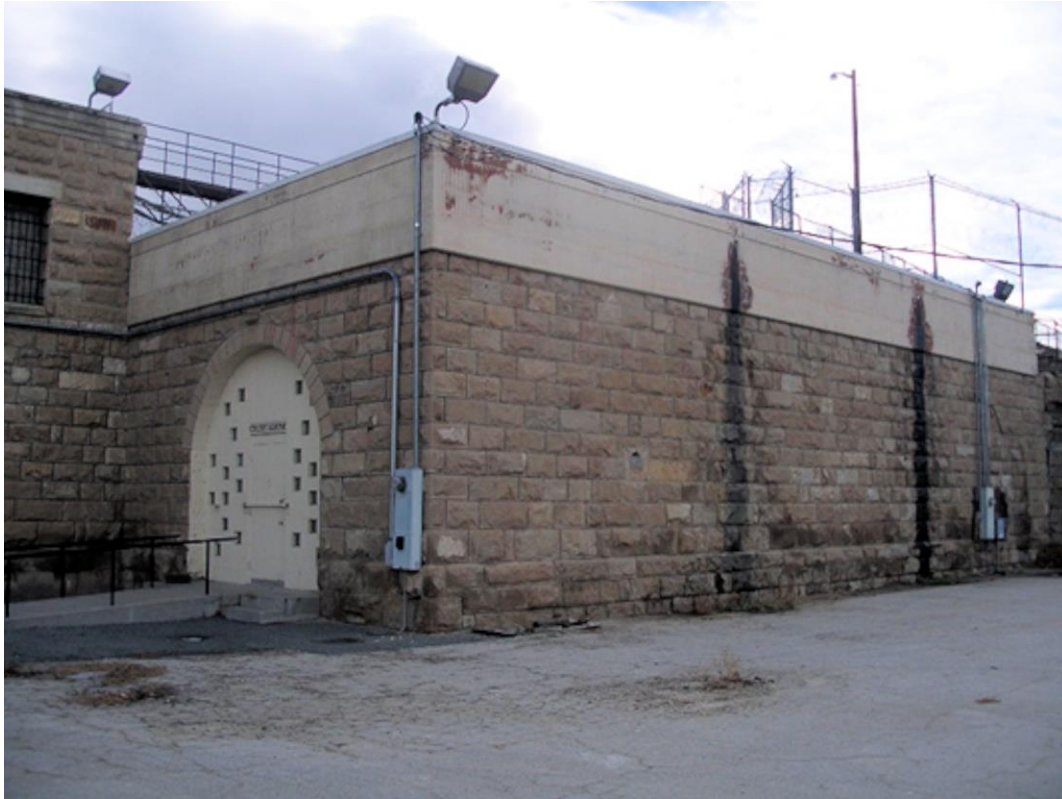
- The Courthouse is a stone masonry structure with a single-ply roof membrane.
- This building is attached to the Administration / Cell Block building and is one of the oldest structures on site.
- It was originally constructed in the 1927-28, as a sally port for major vehicle access to the old prison yard.
- It was covered with a roof in the 1960's as a construction project by the Synanon Foundation to provide 1,475 square feet of interior space.
- It then served as a chapel and offices for caseworkers.
- The facility was remodeled for court proceedings.
- The building is in fair shape

- The Courthouse is constructed of sandstone masonry walls on the exterior and wood framed interior walls and roof.
- The structure requires seismic strengthening to meet current life safety codes.
- This 1927-28 portion of the structure should be retrofitted to meet today's seismic standards.
- This project would cost approximately \$75,000.
- It is recommended that the building be painted in the next 3-5 years.

- The interior finishes are in fair condition.

- This replacement would cost approximately \$15,000.
- The building has a suspended acoustical tile ceiling system.
- The T-bar framing is bent and rusted in many areas and a number of the ceiling tiles are damaged and stained.

- It is recommended that the interior walls be painted at least once in the next two to three years.
- The interior floor covering is mostly carpet and is showing signs of extreme wear.

- Several areas are worn out and tears are evident throughout the carpeted areas causing a tripping hazard.
- This flooring should be replaced with carpet tile to allow for future replacement of only those sections of carpet that are worn or damaged without the need to remove the entire carpeted area.

- The replacement of this ceiling system would be nice but not immediately necessary at this time, regardless of its use.
- The estimate for this ceiling replacement is \$15,000.

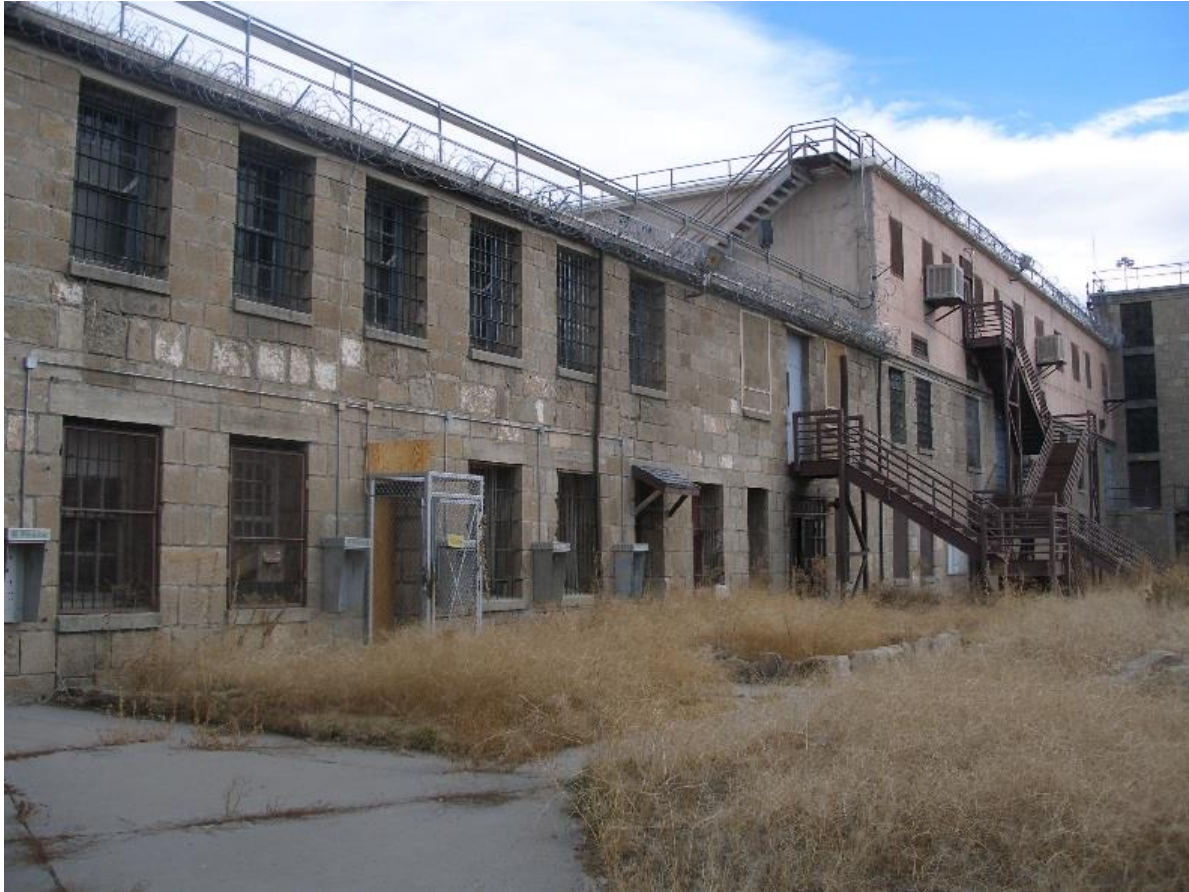
North Wing (Hospital Wing)

- The northern wing of the structure housed a complex assortment of functions.
- There is an access to a cellar area, called "Sagebrush", after the inmate newspaper that was once published by them.
- Today it simply provides access to some utilities.
- The first floor of the wing contained large, open, shop areas.
- These spaces are dim and worn, but could be remodeled for office or file space on an easily accessible ground level through doors that are outside the secure area of the structure.

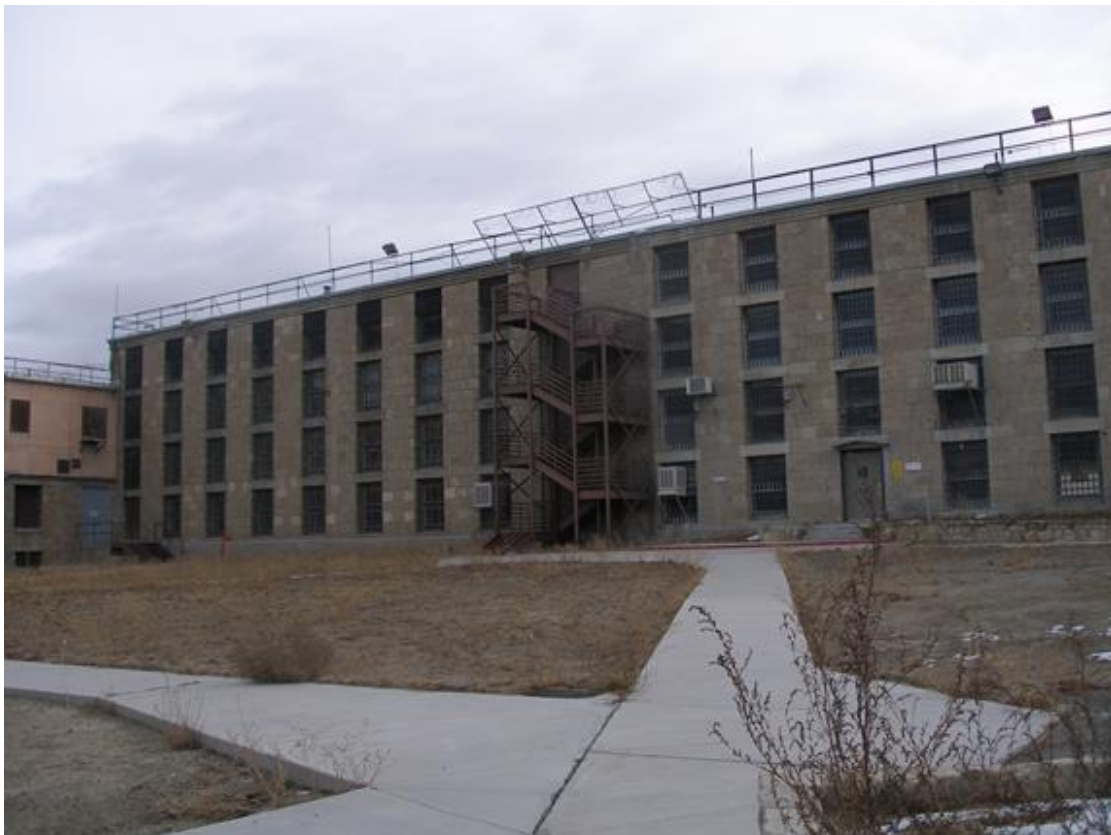
East Wing (Cell Blocks A & B)

- Easily hold 300 inmates
- A & B 4 stories
- A constructed in 1920-25
- B constructed in 1947-50
- Retrofit of bar – gates – hardware with construction of B block
- Interior cell configuration
- Cells inside
- Staff corridors outside next to windows
- Accessed by stairs only on north end of wing

- The existing building exterior is natural sandstone that was quarried directly from the correctional facility site.
- There are numerous areas where the mortar is failing, missing and not sealed properly due the age and exposure to the weather.

- Some of the window units are cracked or damaged, seals are broken, are difficult to operate and they have reached the end of their useful life.
- Prior to painting, all surfaces should be repaired to address the extensive wall issues.

- The existing concrete stairs are showing signs of wear and deterioration.
- Floors in this building are concrete and require no work for any proposed use.

- Electrical and plumbing access is through a "pipe chase" that runs through the center of the building.
- These utilities are worn and inadequate for use as an institution.
- The utilities are not a significant issue for the proposed uses of the structure.
- Some of the domestic water and waste lines have been damaged or shut down, mainly water in Unit 2 and 5 and waste lines in Unit 2.
- An inspection was performed on this building in 1989, for asbestos containing materials (ACM).
- The majority of the building is heated by steam provided from the Boiler Room structure.
- There is no cooling except for numerous evaporative coolers mounted on the roof of Unit 3 which are not ducted to all levels of the structure

- The majority of the utilities in the Cell house are located in the "pipe chase" and are original, with a few areas repaired or replaced.
- At the time of the 2009 survey, all of unit 5 and some of unit 3 were having problems and the system was not 100 percent operational. Some of the pipe, hangers, connectors and couplers are deteriorating and water leaks are developing.

- Dielectric corrosion is occurring between different types of pipe metals, internal corrosion is occurring on the 4" pipe and compression clamps are located in areas where leaks have occurred.

- Other small repairs have been done over time as needed to keep system operational.
- A break in the pipe has the potential to short out the power supply, alarm system, flood the lowest levels of the building and presents a safety hazard.

- A project for replacing the utilities in the "Sagebrush" basement area was completed in 2001.
- This building is equipped with an automatic fire detection and alarm system, but the system is old, does not meet current code requirements and is missing in some locations.

- Some of the sanitary sewer pipe, hangers, connectors and couplers have or are deteriorating to a point where raw sewage may be leaking in some areas.

- Cleaning, repair and re-pointing of the exterior stone work is necessary.
- Due to the vertical nature of the building, scaffolding will be required to accomplish this project.

- Not included in the previous testing was lead paint encapsulation and other possible environmental hazards.
- The cost of this inspection would depend on the intended use of the various portions of the structure.

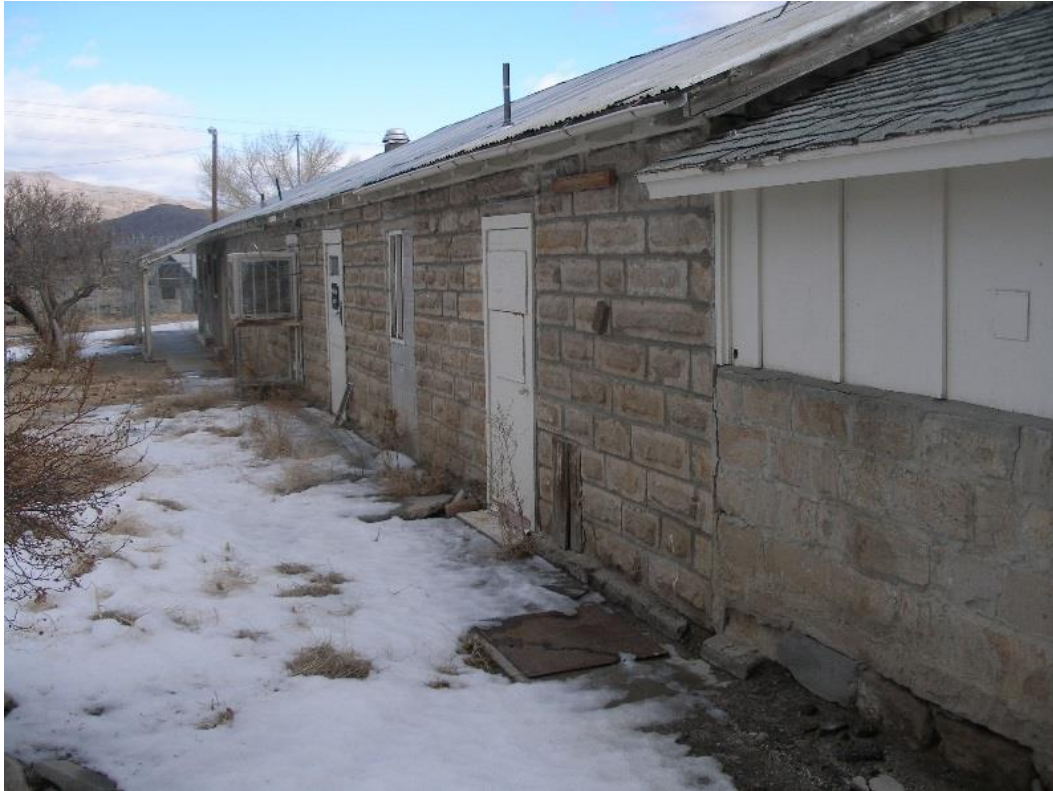
- The Storage and Maintenance Office is a stone masonry and wood framed structure on a concrete slab-on-grade.
- The building has low hazard storage adjacent to the welding shop.
- The roofing is corrugated metal.
- The building contains small office areas, storage areas, a welding area and restrooms in roughly 3 separate spaces and three different occupancies.
- Some portions of this structure are over 50 years old.
- 2,190 sf.
- Constructed in 1952
- The structure is in fair shape.

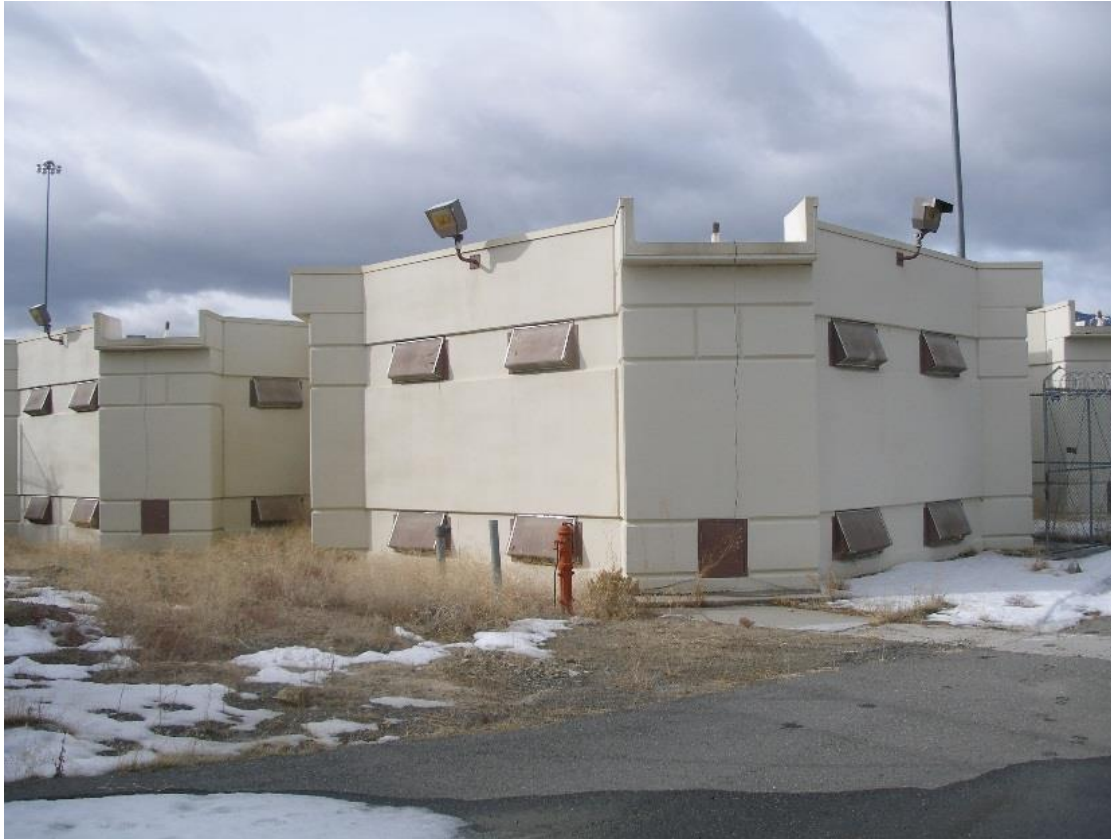
Units 6-7-8-9-10-11

- These housing units are known as the "Hill Units" and are painted precast concrete structures with single-ply membrane roofs
- Each contain 48 cells for 98 inmates, showers and a central control room all on two levels.
- The units are in fair shape.
- Each unit has 7,801 sf of space and were constructed in 1981.

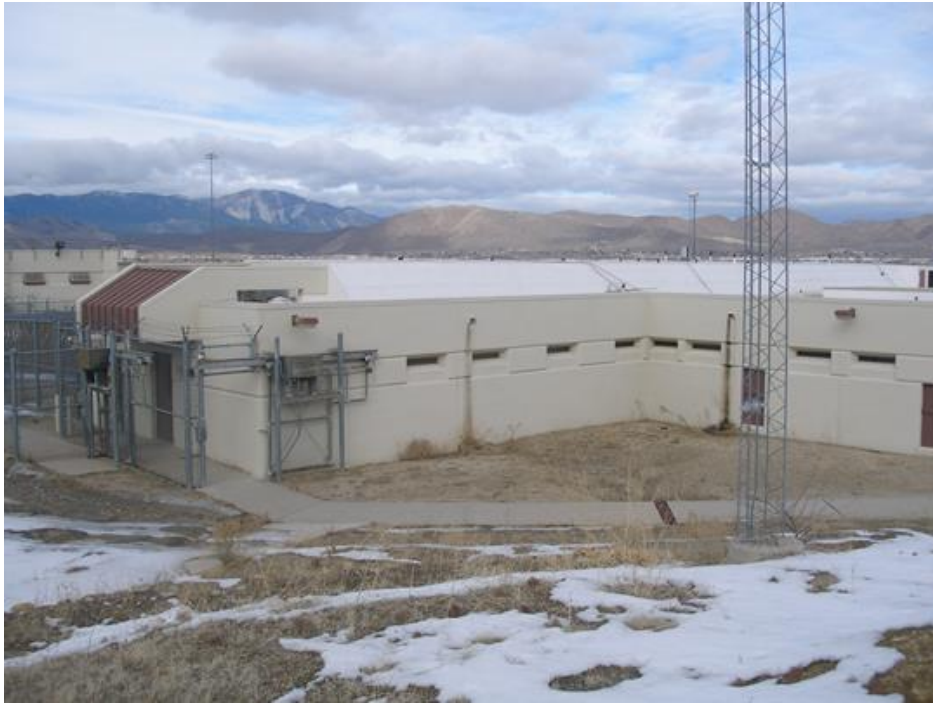
Housing Unit 12

- Housing Unit 12, also known as a "Hill Unit" is a painted precast concrete structure with a single-ply membrane roof.
- It contains 40 cells, showers, visitor's area, a public restroom, mechanical rooms and a central control room.
- The building is considered a "lock-down" unit.
- Each unit has 7,931 sf of space and were constructed in 1982.

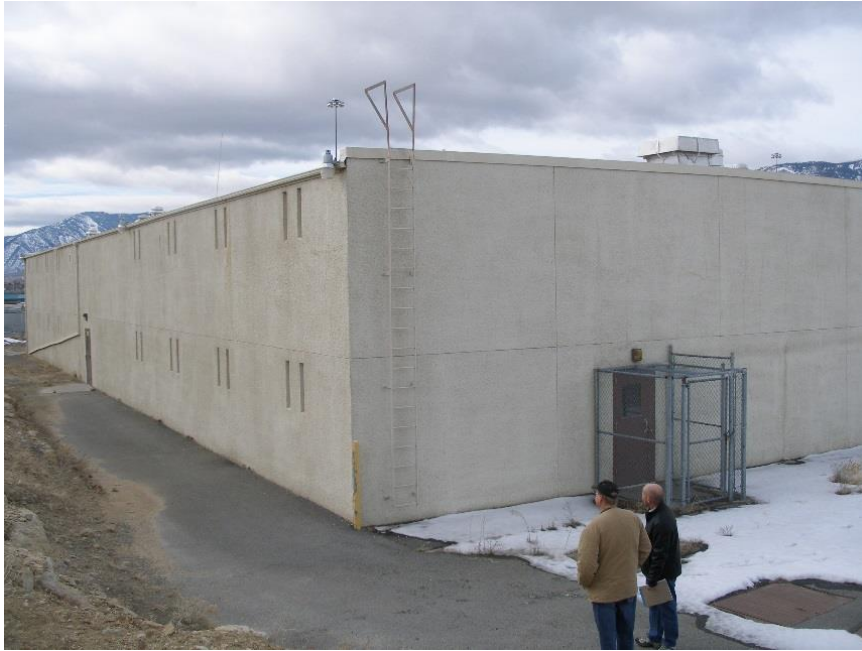
Housing Unit 13

- Housing Unit 13, also known as a "Hill Unit" is a precast concrete structure covered with painted stucco and a single-ply membrane roof.
- It contains cells, showers and a central control room all on two levels.
- This housing unit is a "lockdown" unit for the prison.
- The structure is in fair shape.
- The unit has 11,888 sf of space and was constructed in 1988.

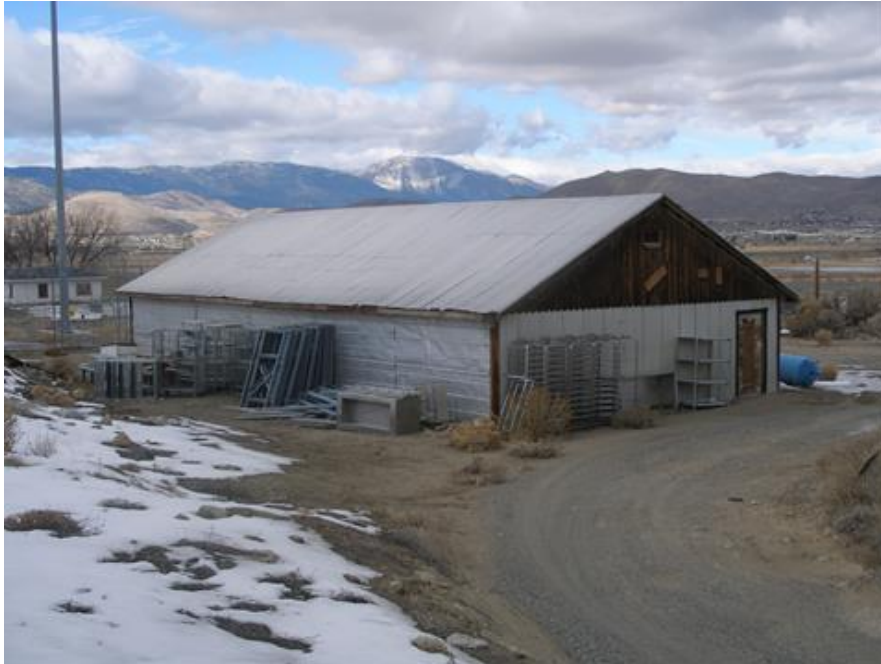
- The Maintenance Warehouse 2 is a wood framed structure with metal siding and roof.
- It is located on the north side of the prison outside the fence.
- This structure is no longer in use.
- 1,288 sf.
- Constructed in 1950.
