**DEPARTMENT OF CORRECTIONS – CARLIN CONSERVATION CAMP AND JEAN CONSERVATION CAMP**

Pursuant to NRS 209.136 Nevada Department of Corrections notification for the permanent closures of the Carlin Conservation Camp and Jean Conservation Camp due to the costs to bring the camps up to structural and correctional standards.

Site Number: 9892  
STATE OF NEVADA PUBLIC WORKS DIVISION  
FACILITY CONDITION ANALYSIS

## SPWD Facility Condition Analysis

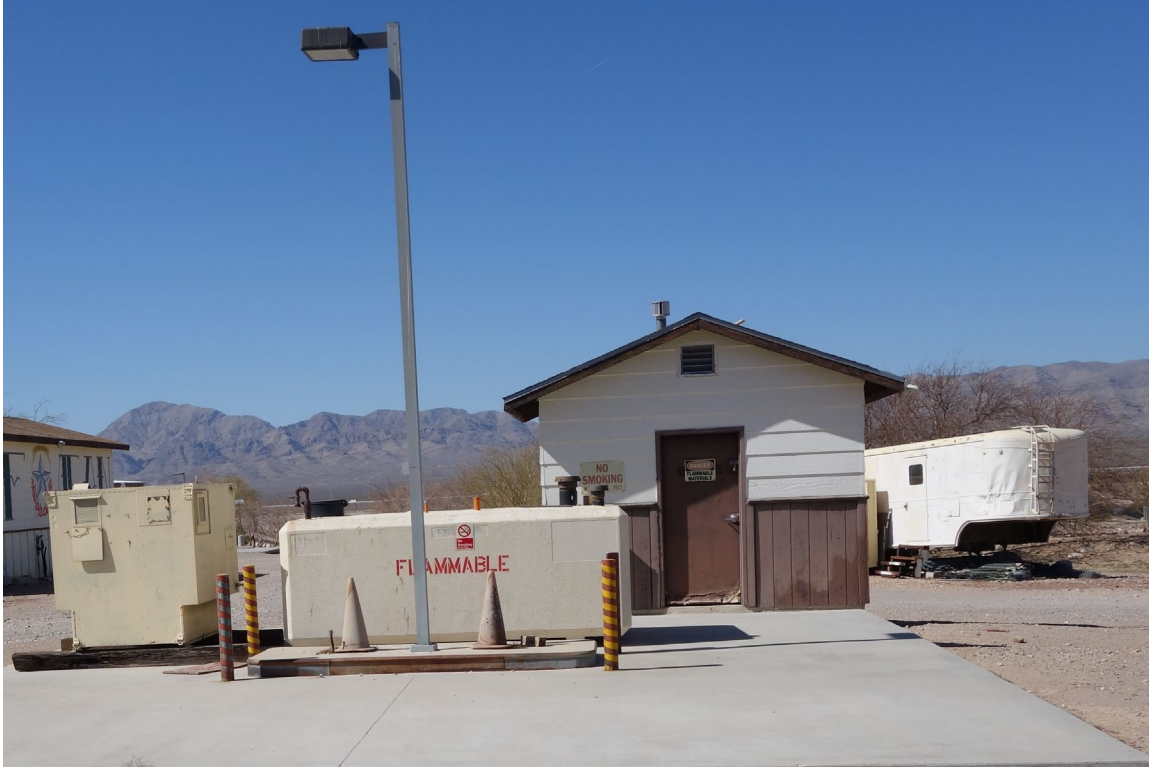
NDF Fuel Building – FCA Building #2517  
Description: Exterior of the Building.

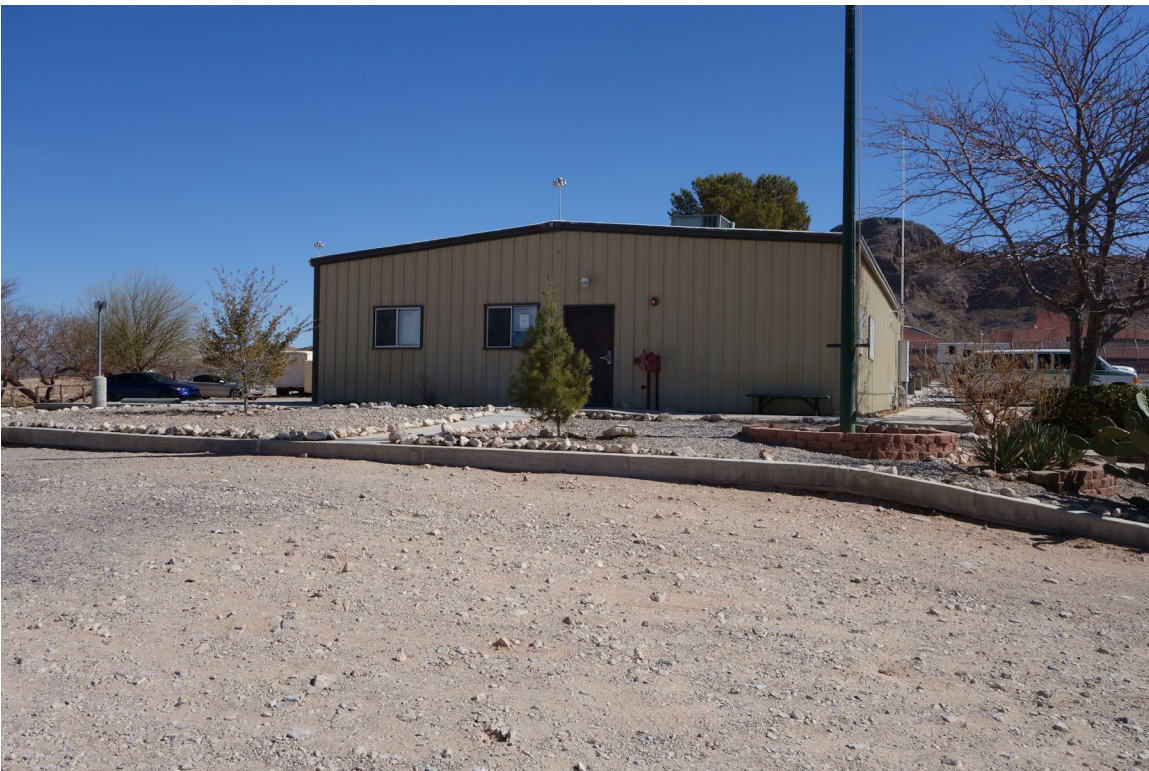
Jean CC NDF Office – FCA Building #2494  
Description: Exterior of the Building.

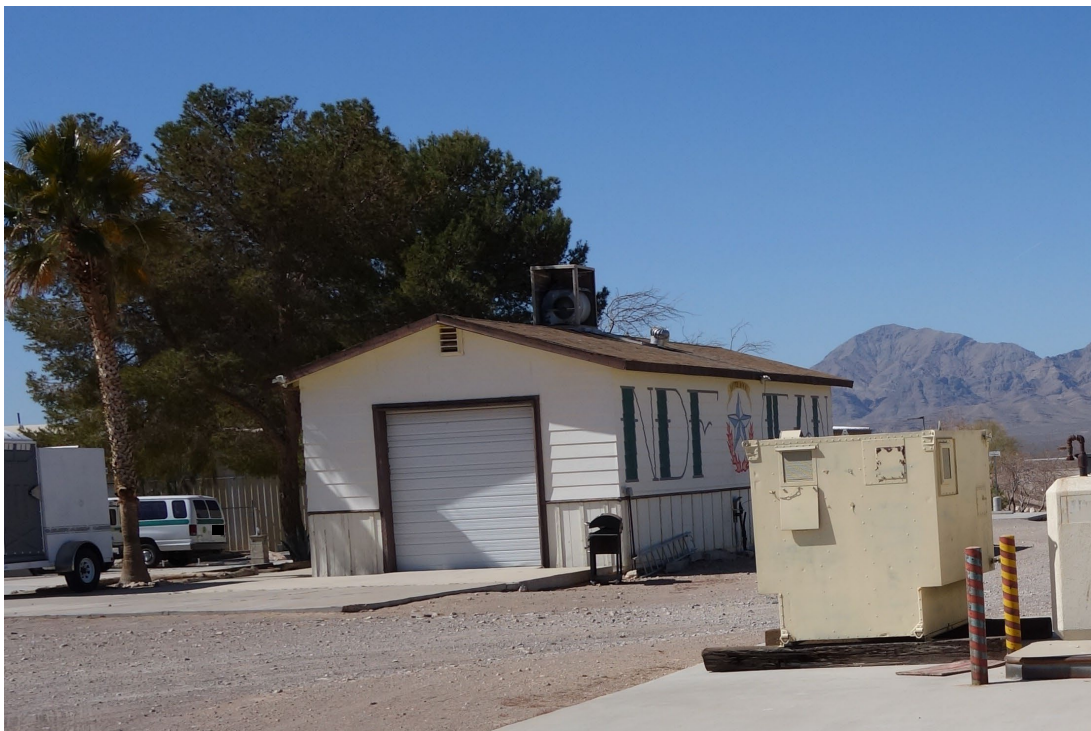
Conservation Camp Storage – FCA Building #2198  
Description: Exterior of the Building.

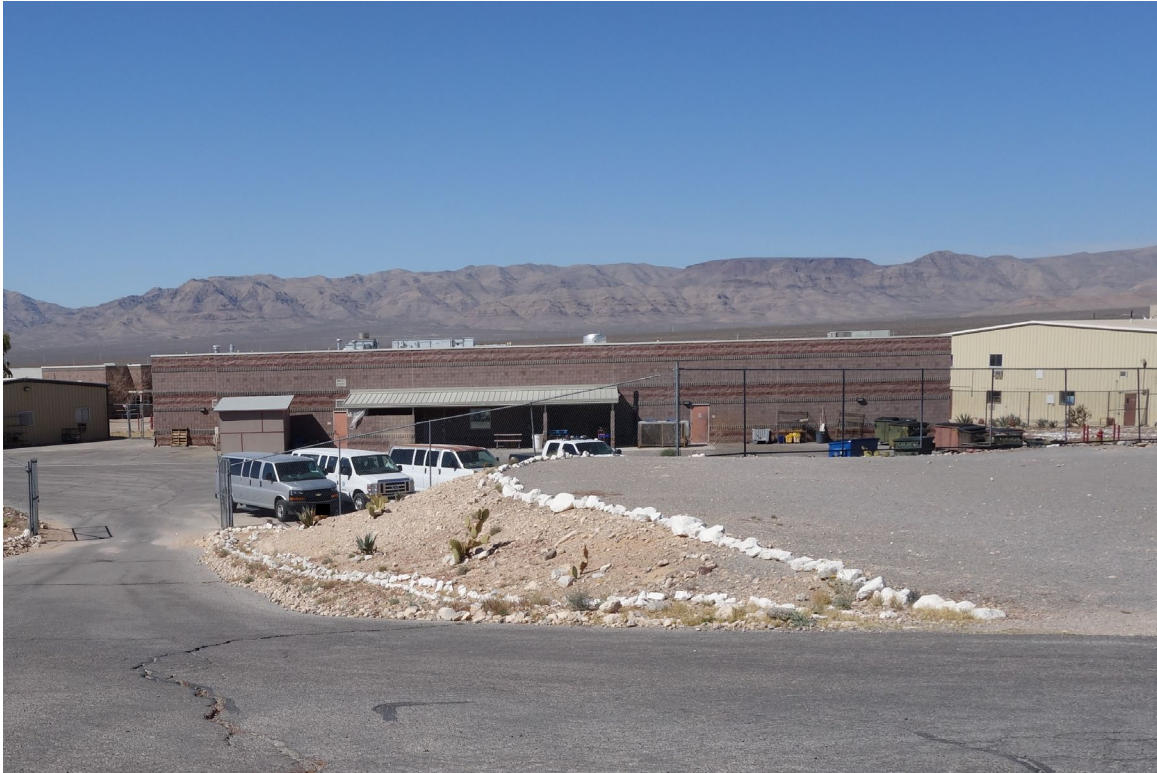
Culinary / Canteen / Dining Hall – FCA Building #2125  
Description: Exterior of the building.

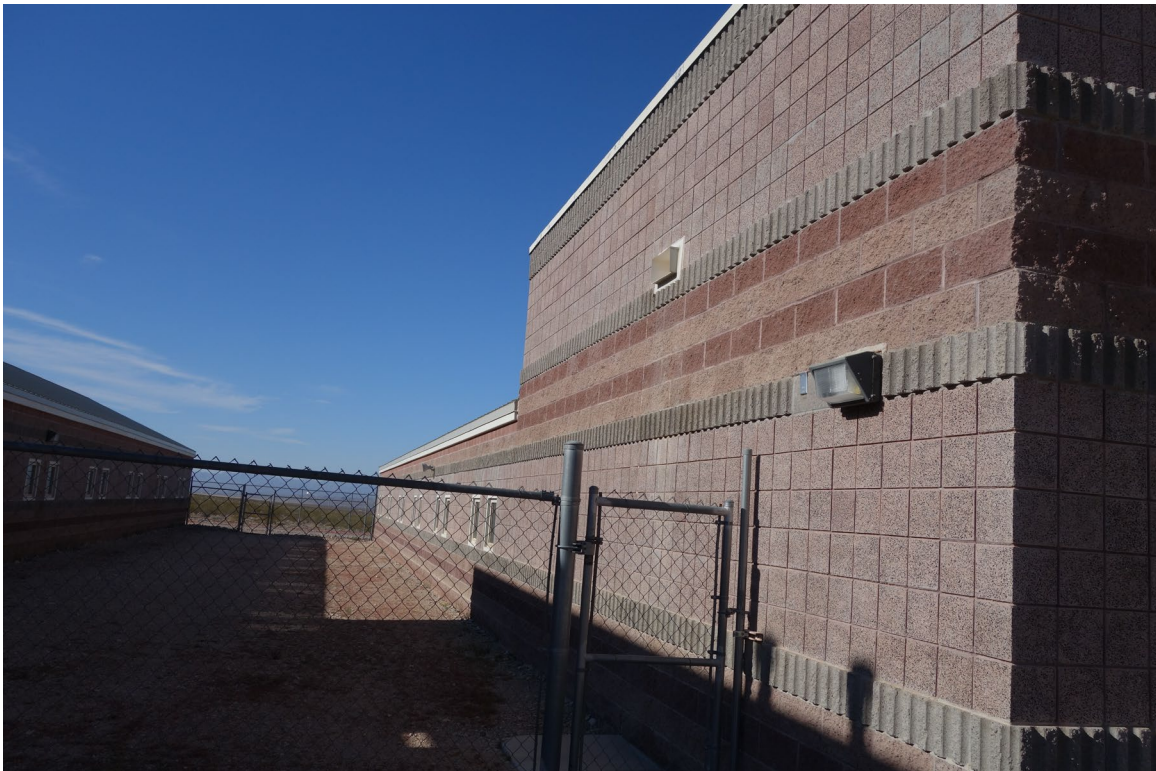
Housing Unit 5 – FCA Building #1987  
Description: Exterior of the Building.

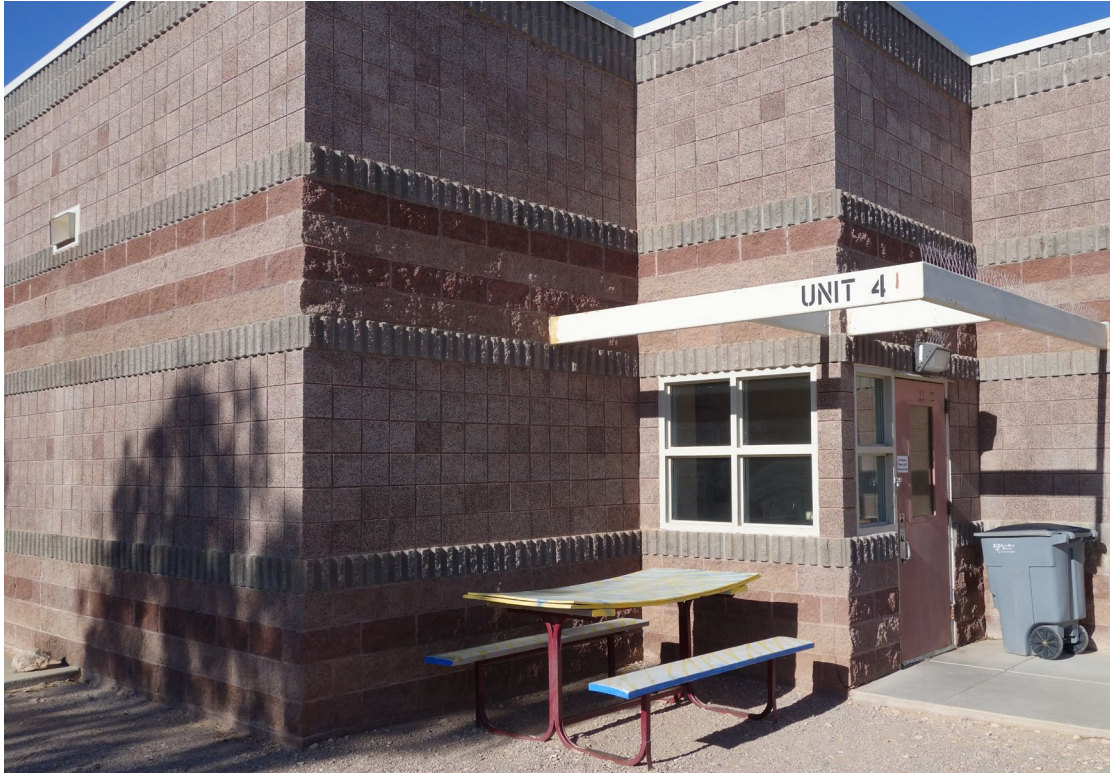
Housing Unit 4 – FCA Building #1986  
Description: Exterior of the Building.

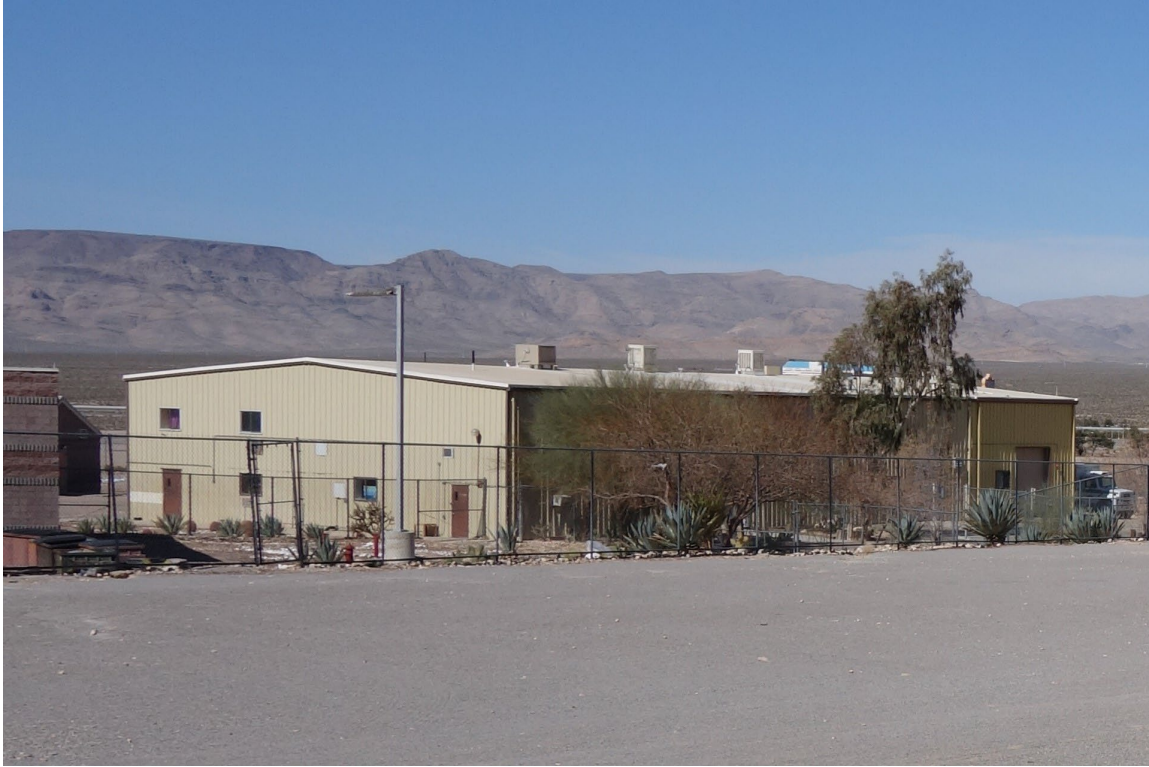
MPR / Visitation / NDF Shop – FCA Building #1898  
Description: Exterior of the Building.

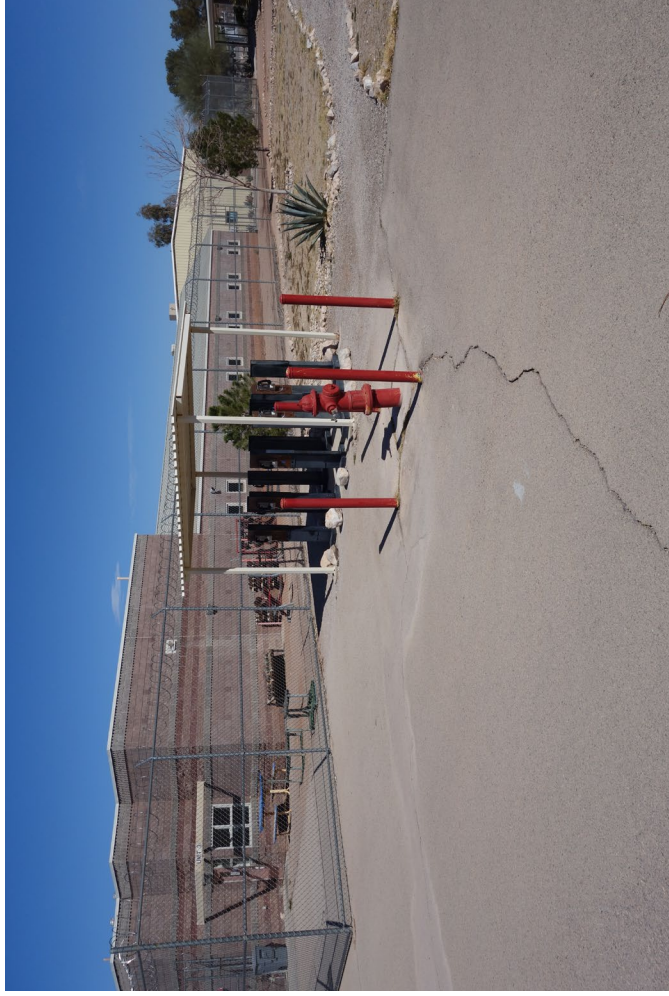
Housing Unit 3 – FCA Building #1897

Description: Exterior of the Building.

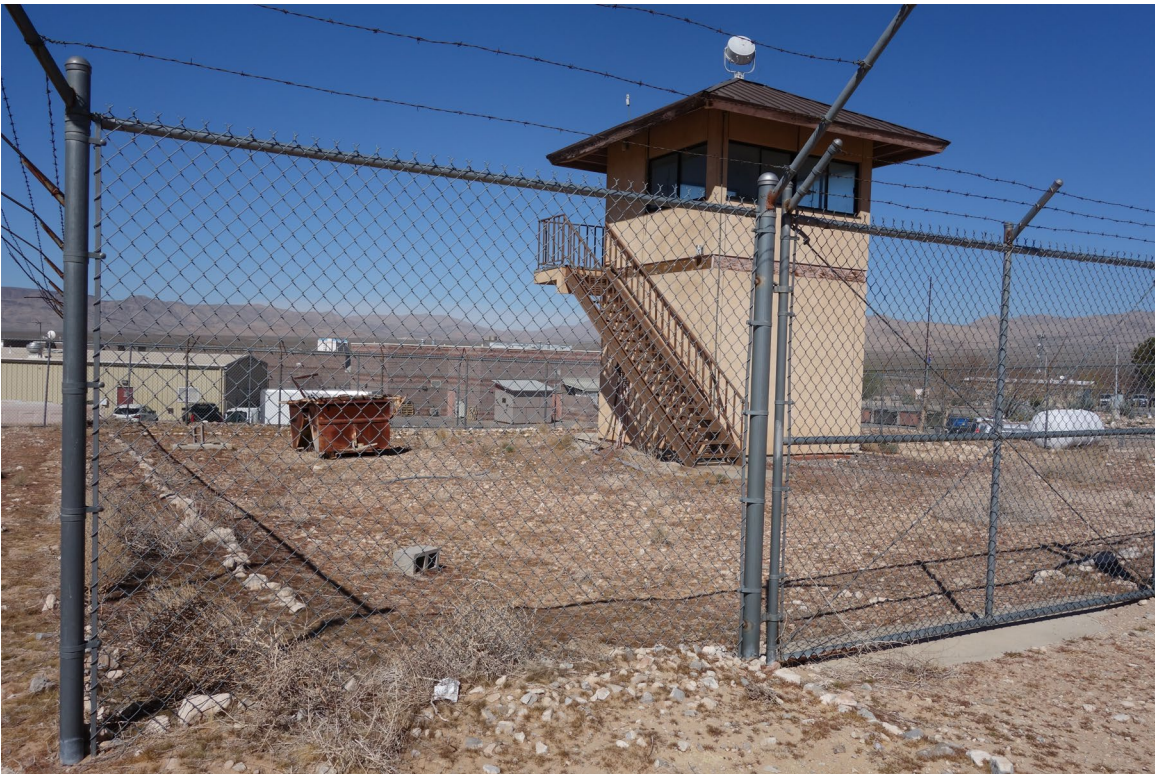
JCC Guard Tower – FCA Building #0883  
Description: Exterior of the Guard Tower.

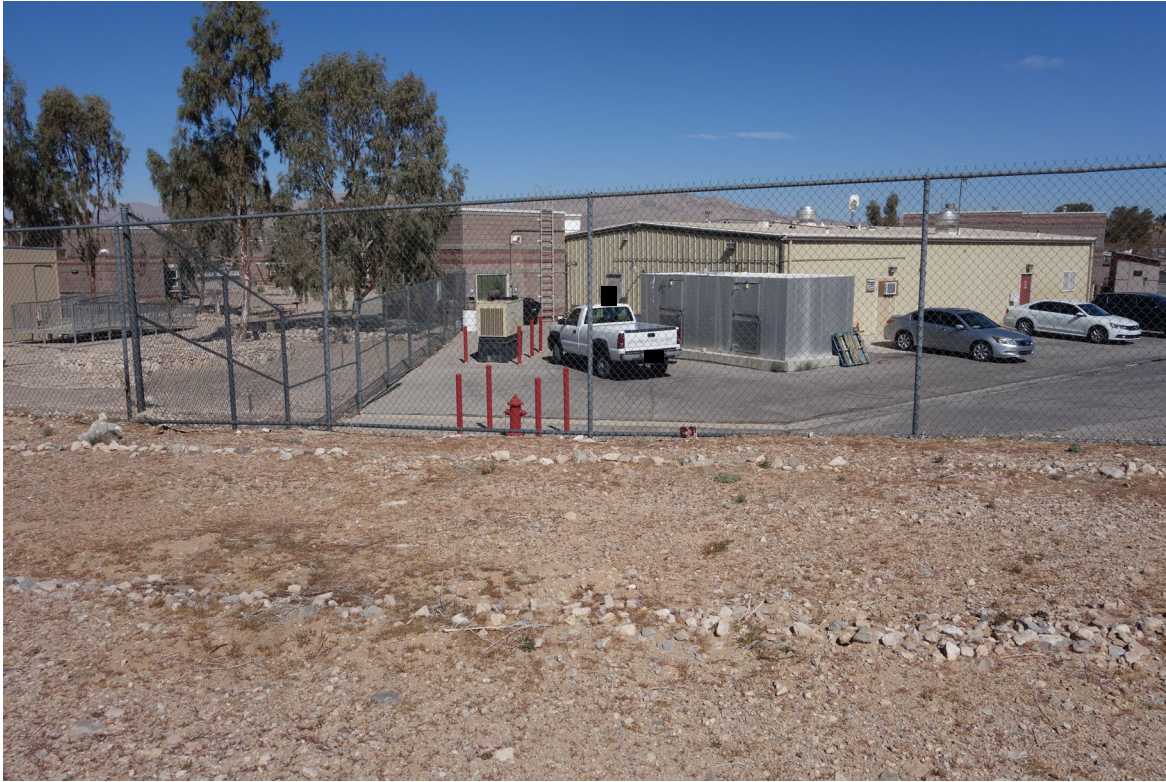
Administration Office / Medical – FCA Building #0663  
Description: Exterior of the Building.

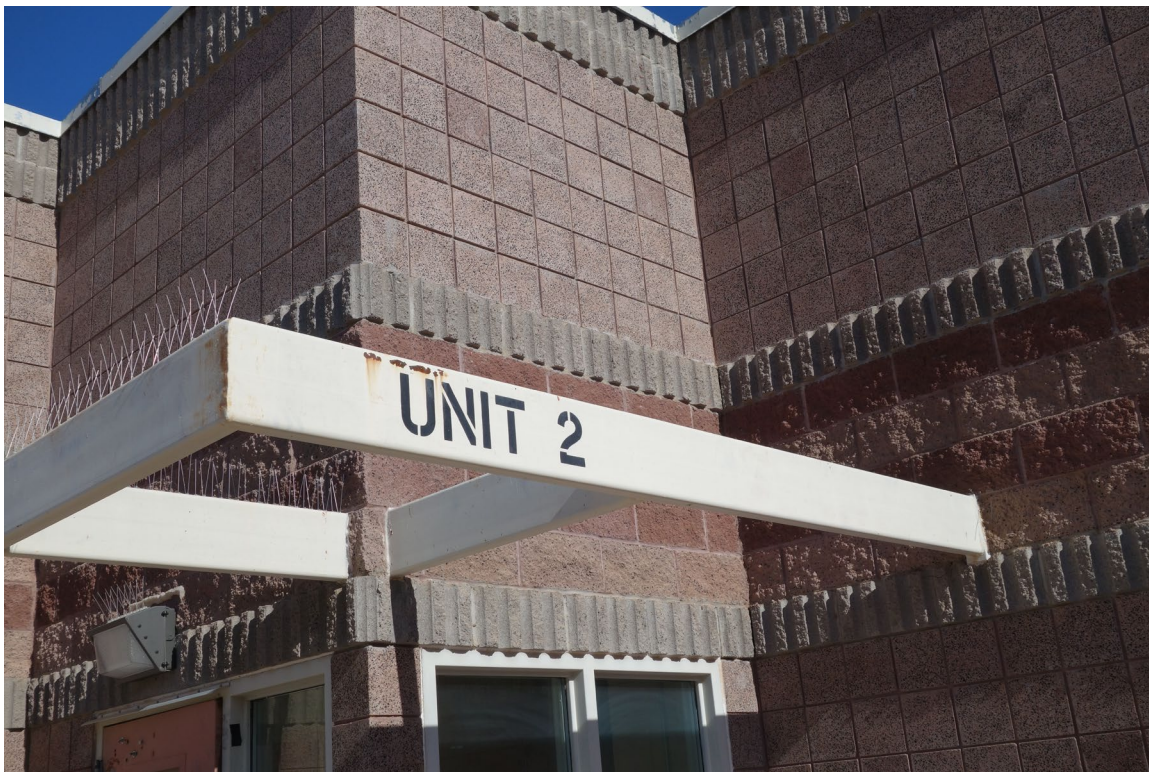
Housing Unit 2 – FCA Building #0662  
Description: Exterior of the Building.

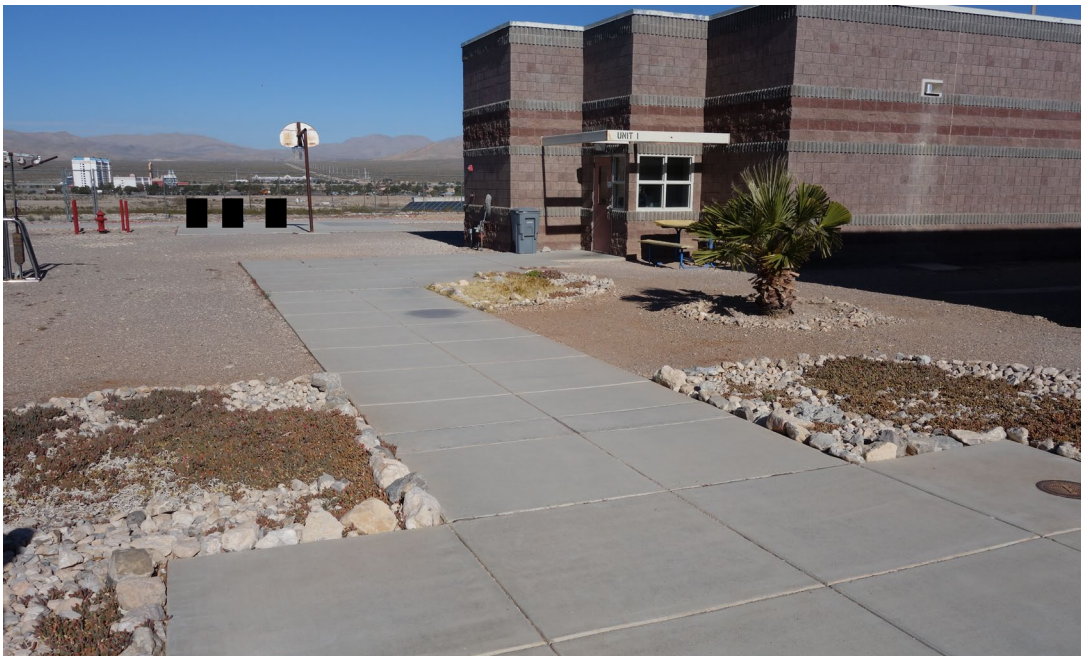
Housing Unit 1 – FCA Building #0632  
Description: Exterior of the Building.

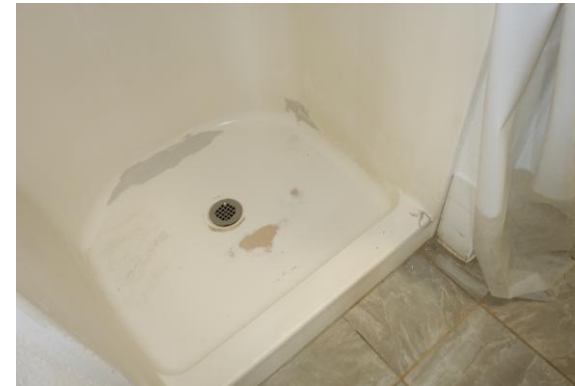
### **0697-ADA-1: RESTROOM REMODEL**

Some of the building's restrooms are original, in poor condition, while others have had improvements but need further improvements. This project recommends funding for the refurbishment of all restrooms throughout the building. As part of the renovation, a minimum of one restroom will be upgraded to meet ADA standards. Scope of work may include wall reconfiguration, installation of new sinks, toilets, hardware, mirrors, fixtures, flooring, finishes and signage. Design and compliance will be guided by the 2024

International Building Code (IBC), ICC A117.1, NRS 338.180, and the latest edition of the ADA Standards for Accessible Design.

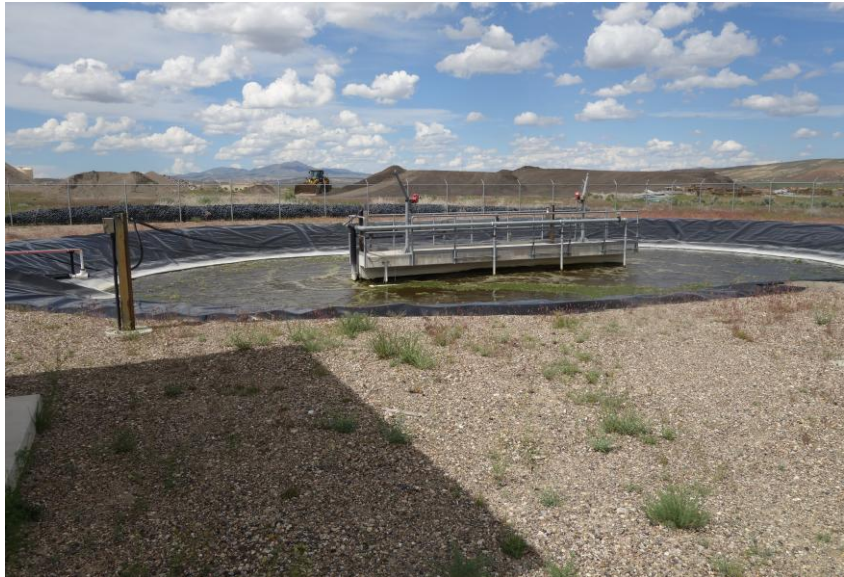
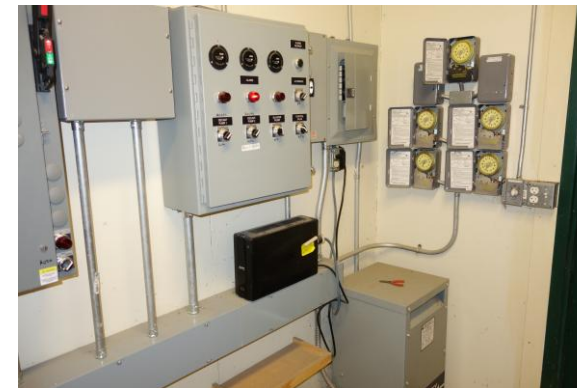
### **9973-ENV-1: WASTEWATER TREATMENT REPAIRS**

The wastewater treatment system, originally installed under Capital Improvement Project 07-M06, is currently inoperable. As a result of this failure, the site has reverted to utilizing the legacy septic disposal system, which was intended to be decommissioned upon commissioning of the new infrastructure. This project proposes funding for the comprehensive refurbishment and reactivation of the wastewater treatment system to restore regulatory compliance, improve operational reliability, and reduce long-term environmental

and maintenance risks associated with continued reliance on outdated infrastructure.

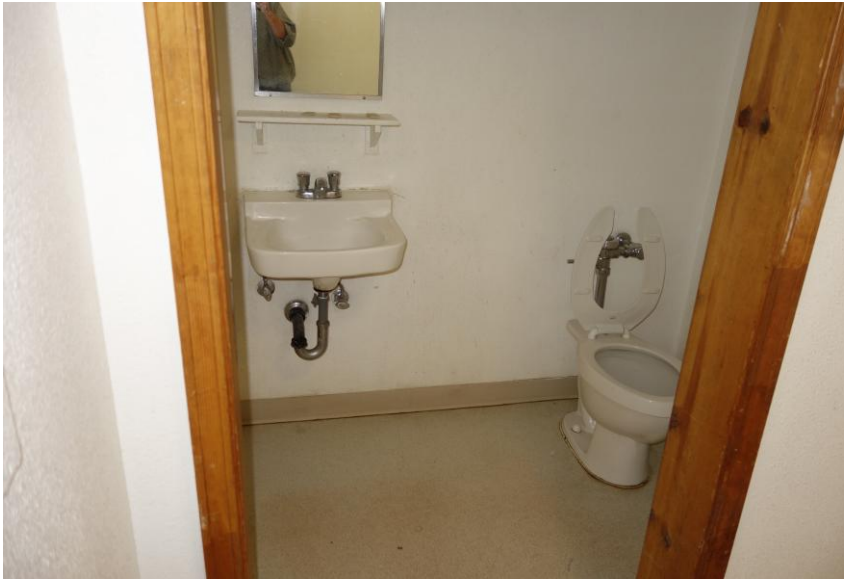
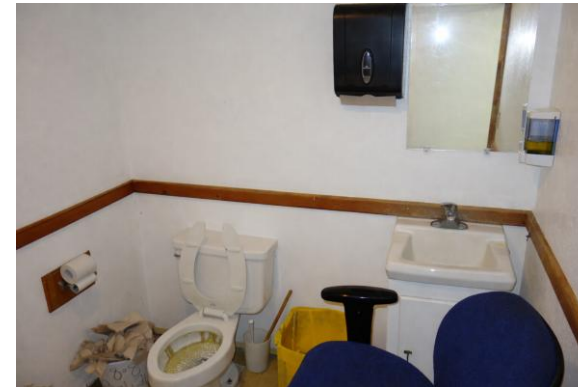
### **1580-ADA-1: ADA RESTROOM REMODEL**

The building's restrooms are original, in poor condition, and currently lack full compliance with ADA accessibility standards—specifically, at least one restroom per floor does not meet current requirements. This project includes funding for the complete refurbishment of all restrooms throughout the building. As part of the renovation, a minimum of one restroom per floor will be upgraded to meet ADA standards. Scope of work may include wall reconfiguration, installation of new sinks, toilets, hardware, mirrors, fixtures, flooring, finishes and signage. Design and compliance will

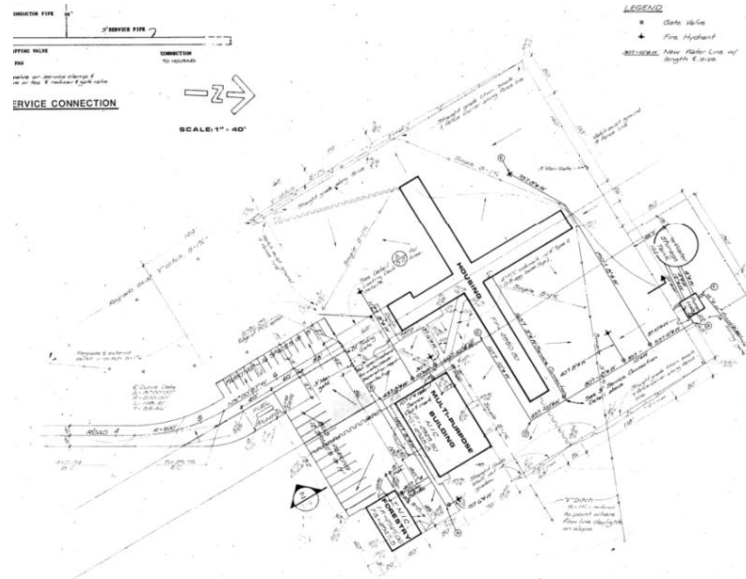
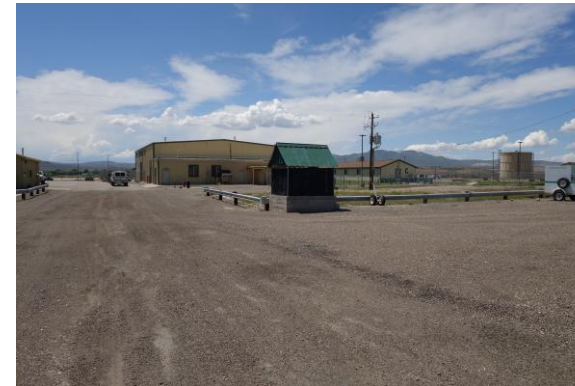
#### 9973-SIT-6: UNDERGROUND SITE DOMESTIC WATER AND SEWER SURVEY

The site has indicated on-going problems with the underground domestic water and sewer systems. The problems appear to be associated with the deterioration of piping underground. Original construction drawings do not appear to indicate the type of materials used for the underground piping or lateral connections to buildings. This project recommends a comprehensive survey of the existing domestic water and sewer piping to determine a solution for the ongoing challenges.

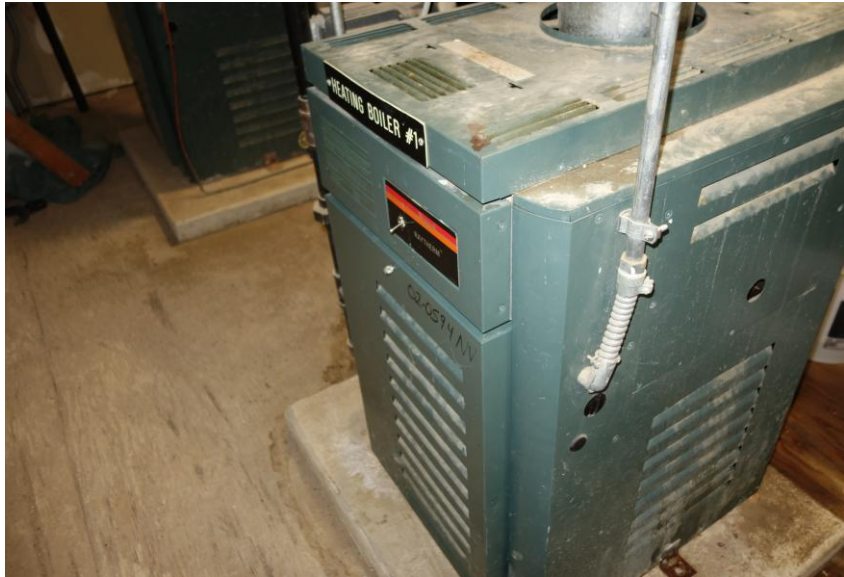
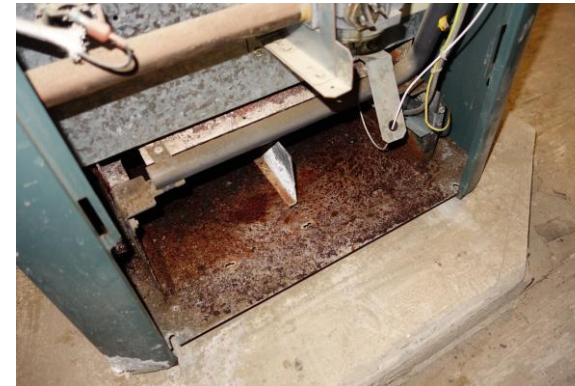
### **0697-HVA-4: BOILER & WATER HEATER REPLACEMENT**

There are two gas fired boilers and two water heaters that are original to the housing unit and have reached the end of their expected life. This project recommends replacing both systems. The scope includes removal and disposal of the existing boilers and water heaters, installation of new pump and accessory equipment and associated piping within the mechanical room, and reconnection to existing utilities. Outside the mechanical room, the hot water piping and convective heaters appear to be in good condition and are not included in this cost estimate.

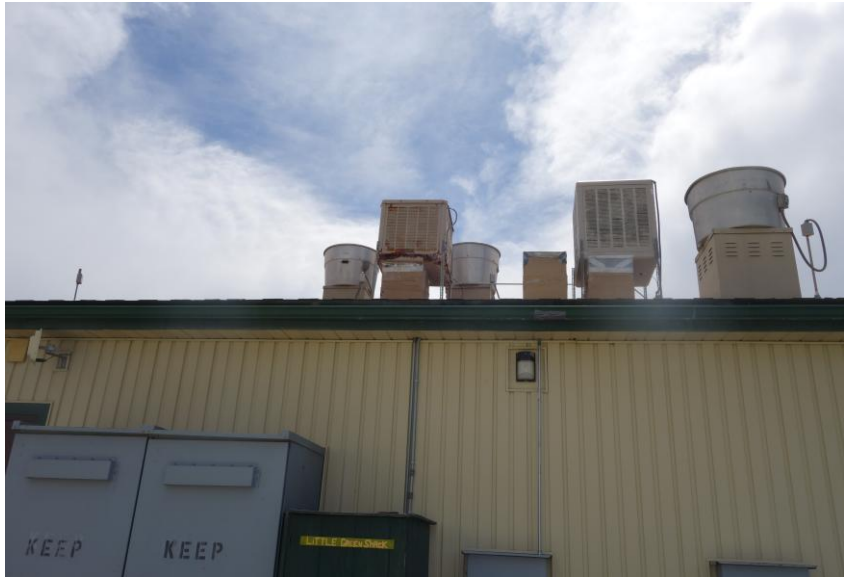
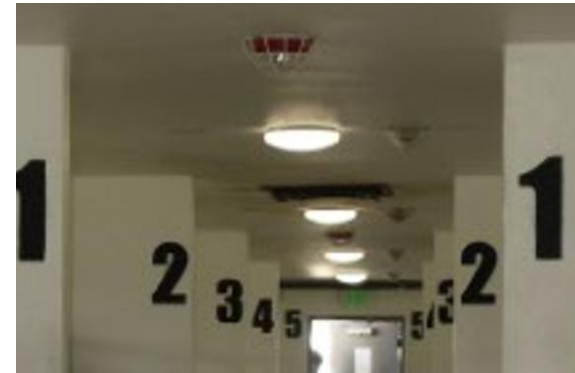
### **0697-HVA-5: EVAPORATIVE COOLER AND DUCTWORK REPLACEMENT**

The existing evaporative cooler system serving the building is corroded due to high humidity supply air. This project recommends the complete removal and replacement of the existing system. Specifically, roof curb mounted evaporative cooling units, plumbed equipment drains internal to the roof curbs, new distribution ductwork and ceiling registers.

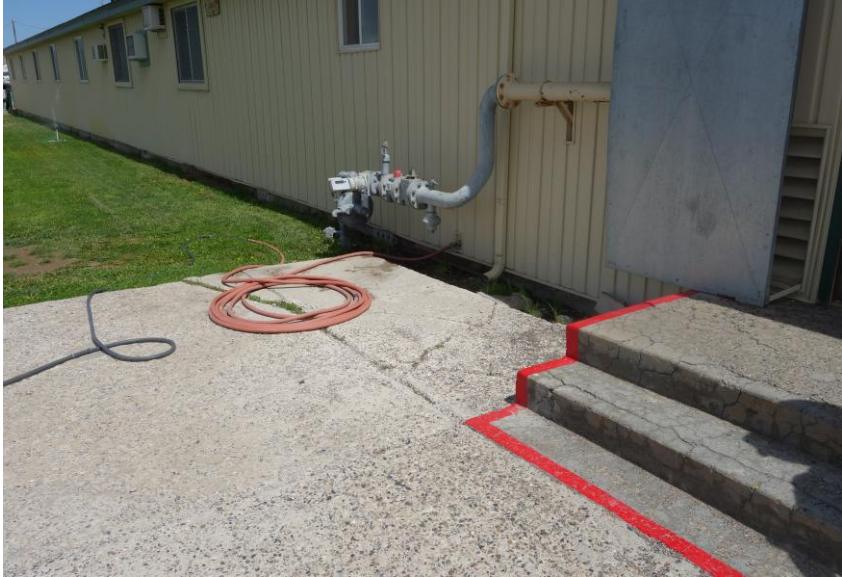
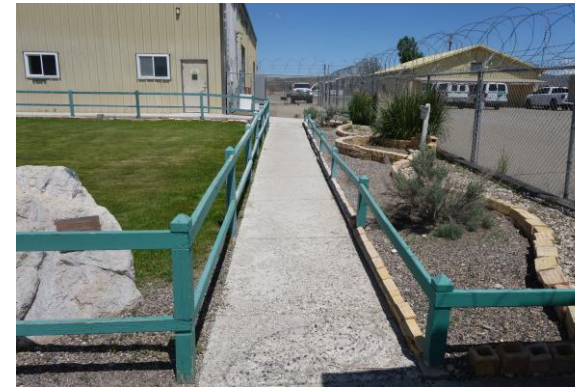
#### 9973-SIT-5: CONCRETE FLATWORK AND SIDEWALK REPLACEMENT

The campus includes a network of concrete pedestrian pathways, flatwork and steps to each building. However, many sections have deteriorated or settled over time, resulting in noncompliant slopes and trip hazards. This project proposes the replacement of damaged sidewalks, incorporating all necessary accessibility upgrades. The construction estimate is based on an assumed replacement area of 3,500 square feet.

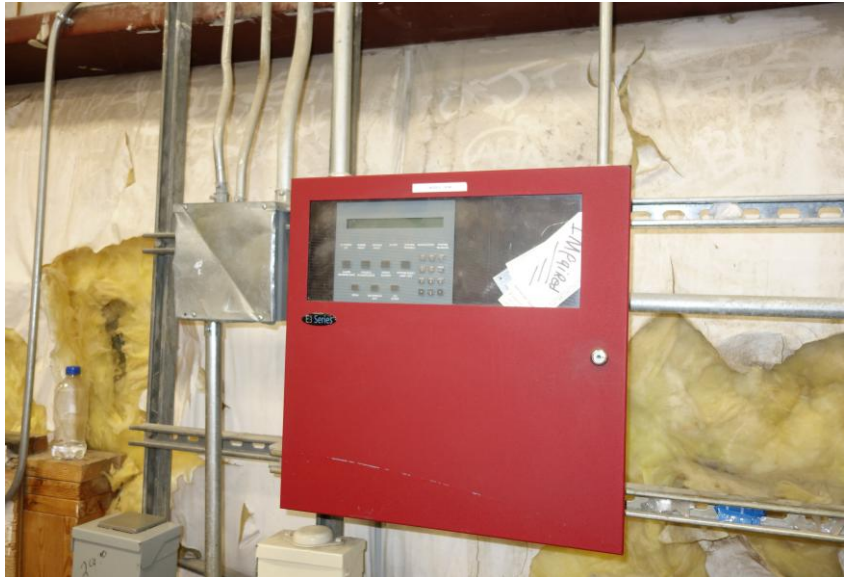
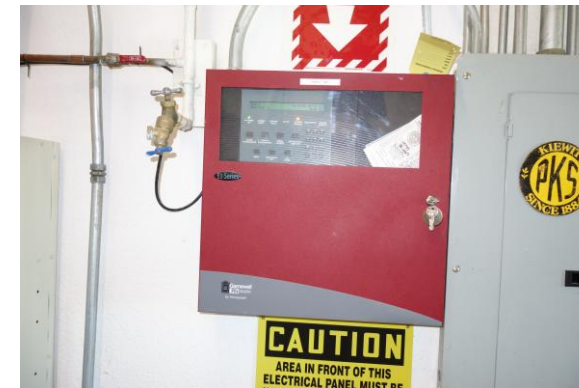
#### 9973-SFT-2: FIRE ALARM UPGRADE SITEWIDE

The fire alarm systems in most buildings have reached the end of its service life, with equipment no longer manufactured and replacement parts increasingly difficult to source. To maintain reliable fire protection and ensure system integrity, this project recommends a complete replacement. The new system will be fully integrated across all buildings and include centralized notification to security personnel in the Administration Building, enhancing safety, response times, and long-term maintainability.

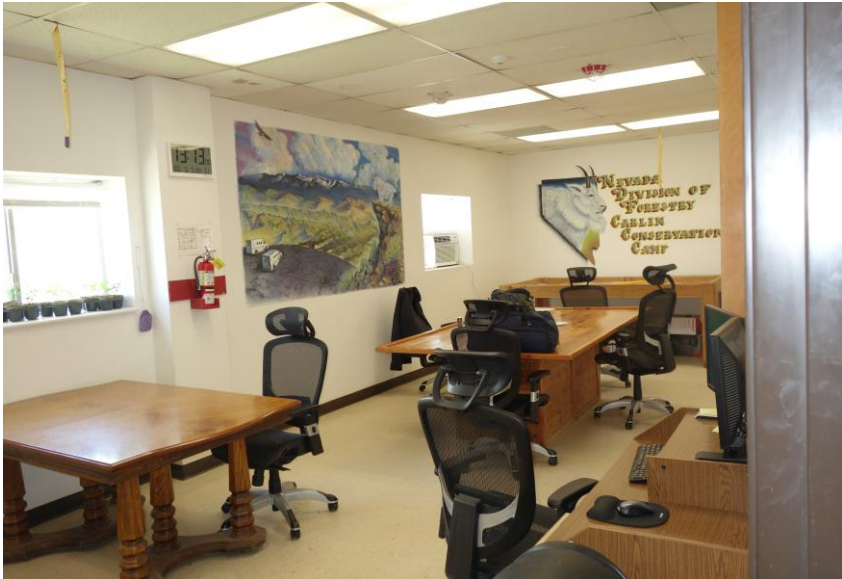
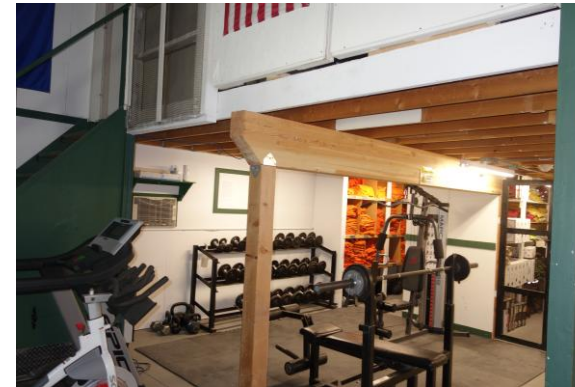
### 1581-HVA-1: HVAC UPGRADE

The existing HVAC system consists of an evaporative cooler, window a/c units and a propane-fired forced air unit (FAU), with the FAU currently inoperable and the evaporative cooler insufficient for the building's occupancy needs. This project recommends replacing the FAU, evaporative cooler and window units with a high-efficiency FAU unit and adding air conditioning to provide adequate and reliable climate control.

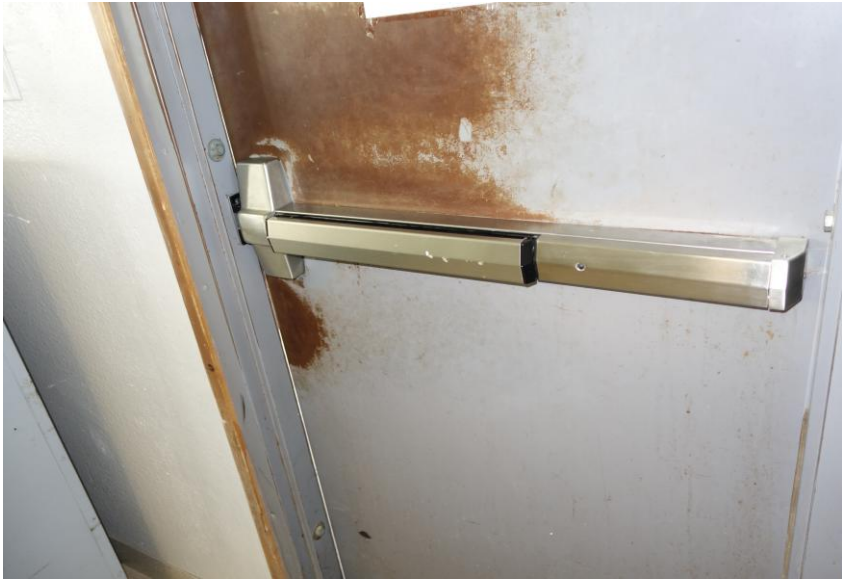
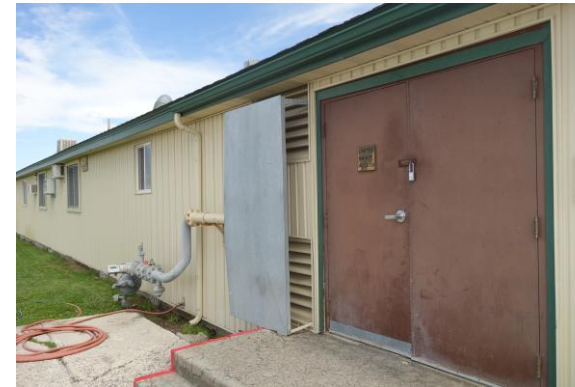
### **0697-SEC-1: EXTERIOR DOOR REPLACEMENT**

The existing exterior doors and locks appear to be original to the building. They are showing signs of wear and deterioration from constant use and abuse. The frames are damaged as well as the hinges. Because of security concerns and the door's condition, this project would provide funding to replace all exterior doors, frames, locks and hardware.

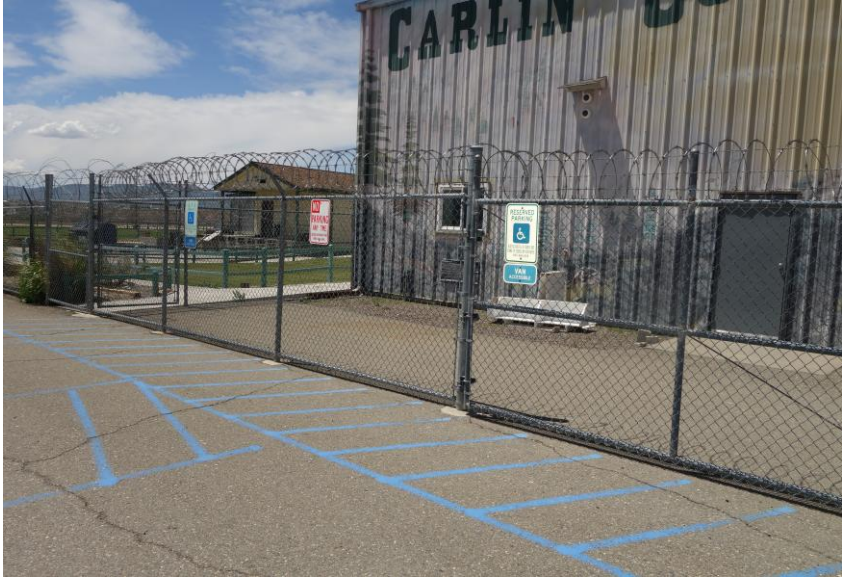
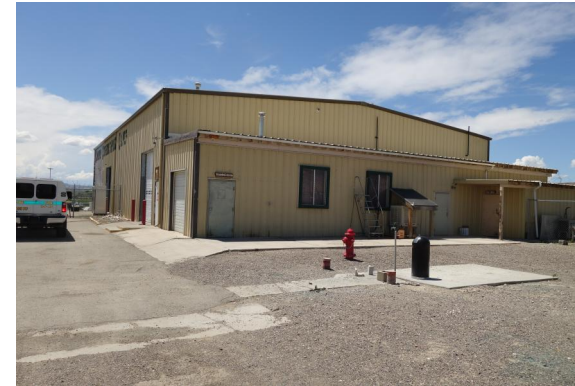
#### 9973-SIT-4: PATCH, CRACK FILL AND SEAL ASPHALT PAVING

The entry road and parking lot paving is deteriorated, exhibiting extensive cracking. This project includes the replacement of the most deteriorated pavement, crack filling, and seal. Striping is included in this estimate.

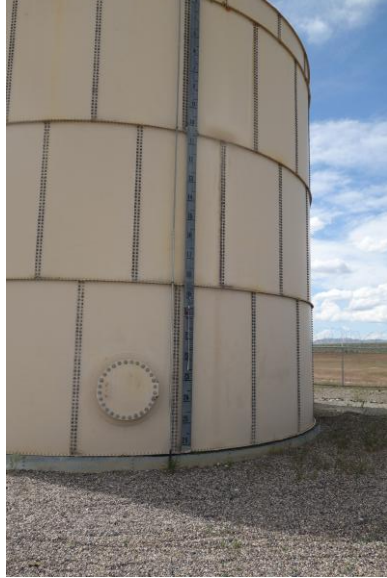
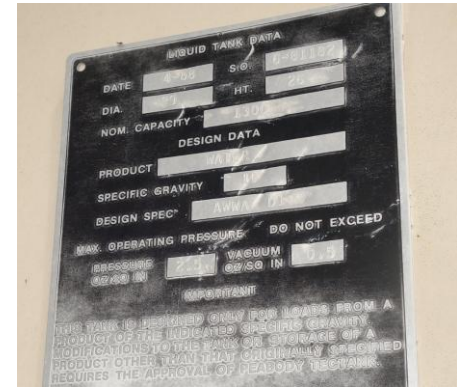
### NEW BUILDING EXTERIOR - 11/20/2025 2549-EXT-2: WATER TANK INSPECTION

In addition to the manufacturer's recommended annual maintenance, a comprehensive inspection and cleaning is advised every 5 to 10 years, depending on water quality and system usage. This detailed inspection includes, but is not limited to, evaluation of exterior foundations, surfaces, equipment, controls, interior roof and sidewall structures, liners, and removal of debris or sediment. This project proposes funding to engage a certified tank inspection company. Costs for any necessary cleaning or repairs are not

included in this estimate. The tank was last inspected in 2018 and it is recommended to be re-inspected in the 2-4 years.

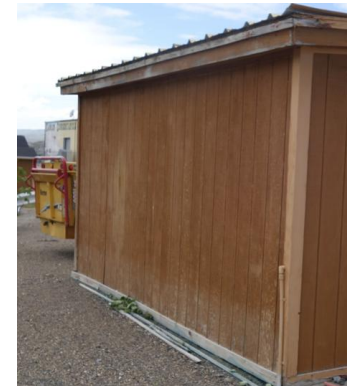
### NEW BUILDING EXTERIOR - 11/18/2025 4309-EXT-1: EXTERIOR FINISHES

The exterior finishes of the building are in poor condition, and maintaining the building's finish, weather resistance, and appearance is essential. This project will fund improvements to protect the exterior envelope of the building, excluding the roof. The scope includes painting, staining, or sealing the exterior walls, along with caulking around windows, flashing, fixtures, and all other exterior penetrations. It is recommended that this work be completed within the next 2 - 4 years and scheduled on a recurring

maintenance cycle to preserve the structural integrity and visual condition of the facility.

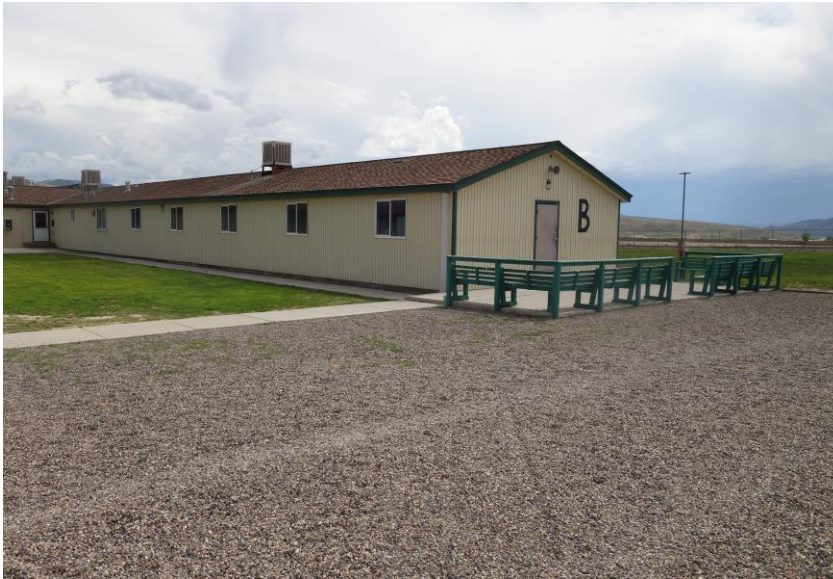
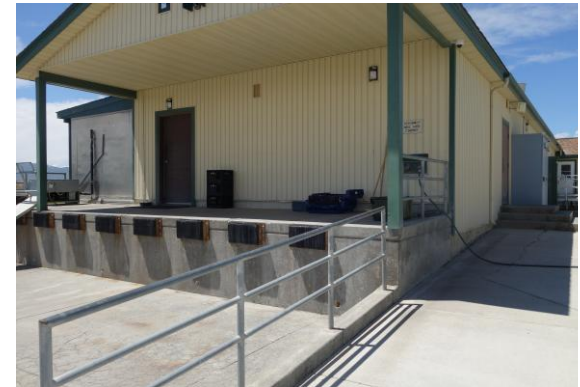
#### 0697-EXT-4: EXTERIOR FINISHES

The exterior finishes of the building are in fair condition, and maintaining the building's finish, weather resistance, and appearance is essential. This project will fund improvements to protect the exterior envelope of the building, excluding the roof. The scope includes painting, staining, or sealing the exterior walls, along with caulking around windows, flashing, fixtures, and all other exterior penetrations. It is recommended that this work be completed within the next 5 - 7 years and scheduled on a recurring

maintenance cycle to preserve the structural integrity and visual condition of the facility.

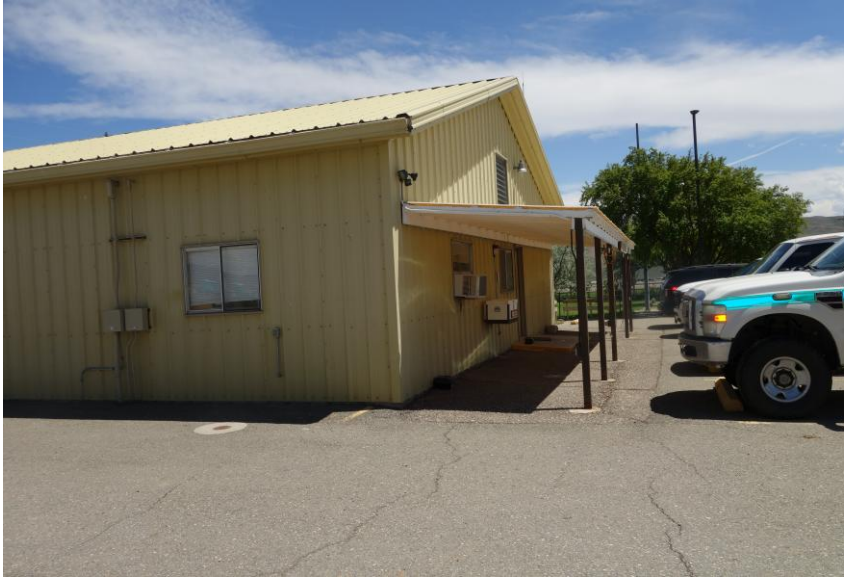
### 1581-EXT-1: EXTERIOR FINISHES

The exterior finishes of the building are in fair condition, and maintaining the building's finish, weather resistance, and appearance is essential. This project will fund improvements to protect the exterior envelope of the building, excluding the roof. The scope includes painting, staining, or sealing the exterior walls, along with caulking around windows, flashing, fixtures, and all other exterior penetrations. It is recommended that this work be completed within the next 4 - 5 years and scheduled on a recurring maintenance cycle to preserve the structural integrity and visual condition of the facility.

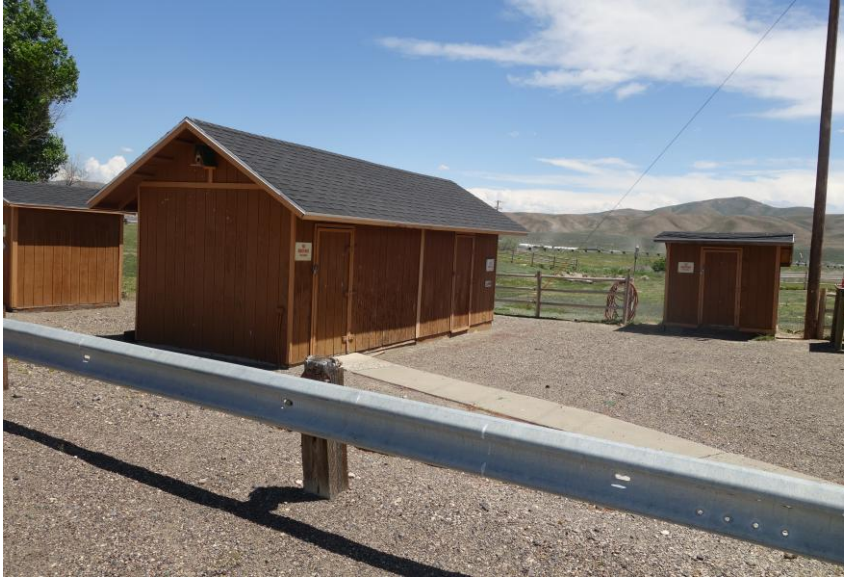
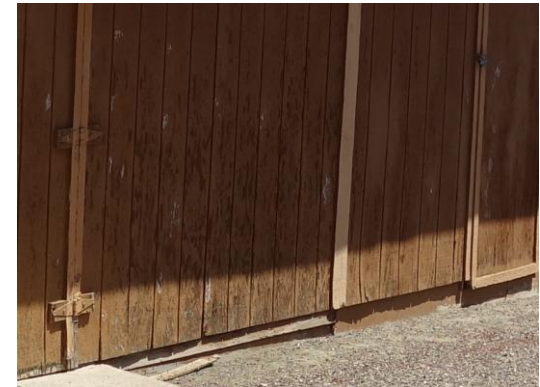
### REINSTATED BUILDING EXTERIOR - 11/14/2025 2149-EXT-2: EXTERIOR FINISHES

The exterior finishes were in fair condition. It is important to maintain the finish, weather resistance and appearance of the building. This project recommends work to protect the exterior building envelope, other than the roof, including painting, staining, or other applied finishes, and caulking around windows, flashing, fixtures, and other penetrations to maintain the building in good, weather tight condition. It is recommended that this project be implemented in the next 4 - 5 years and is recommended on a cyclical basis based on environmental conditions.
