**DEPARTMENT OF CORRECTIONS – CARLIN CONSERVATION CAMP AND JEAN CONSERVATION CAMP**

Pursuant to NRS 209.136 Nevada Department of Corrections notification for the permanent closures of the Carlin Conservation Camp and Jean Conservation Camp due to the costs to bring the camps up to structural and correctional standards.

Site Number: 9892  
STATE OF NEVADA PUBLIC WORKS DIVISION  
FACILITY CONDITION ANALYSIS

## SPWD Facility Condition Analysis

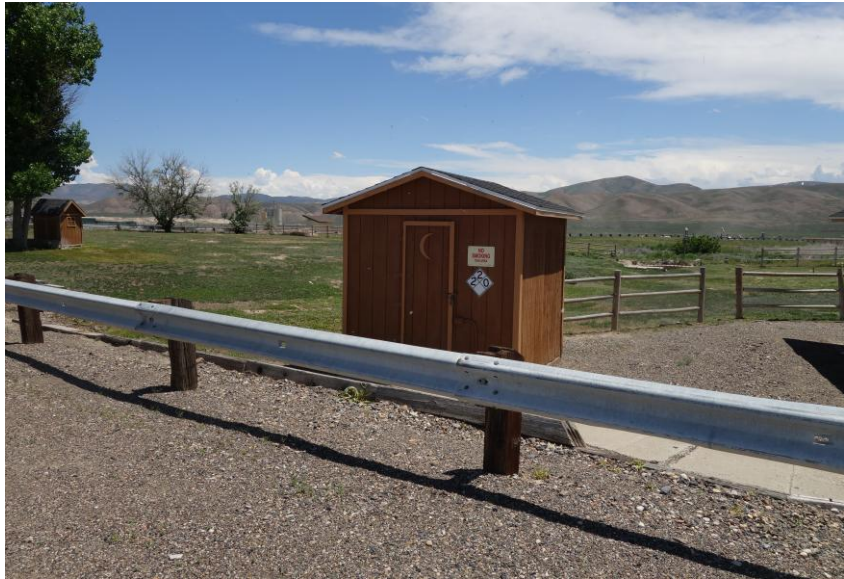
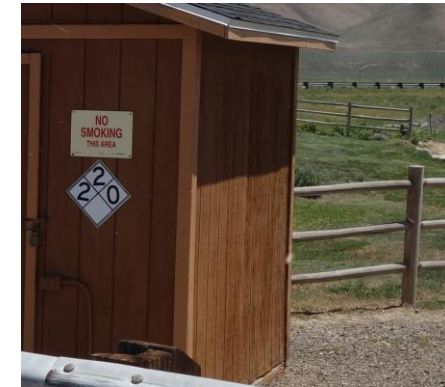
### REINSTATED BUILDING EXTERIOR - 11/17/2025 2150-EXT-1: EXTERIOR FINISHES

The exterior finishes were in good condition. It is important to maintain the finish, weather resistance and appearance of the building. This project recommends work to protect the exterior building envelope, other than the roof, including painting, staining, or other applied finishes, and caulking around windows, flashing, fixtures, and other penetrations to maintain the building in good, weather tight condition. It is recommended that this project be implemented in the next 6 - 8 years and is recommended on a cyclical basis based on environmental conditions.

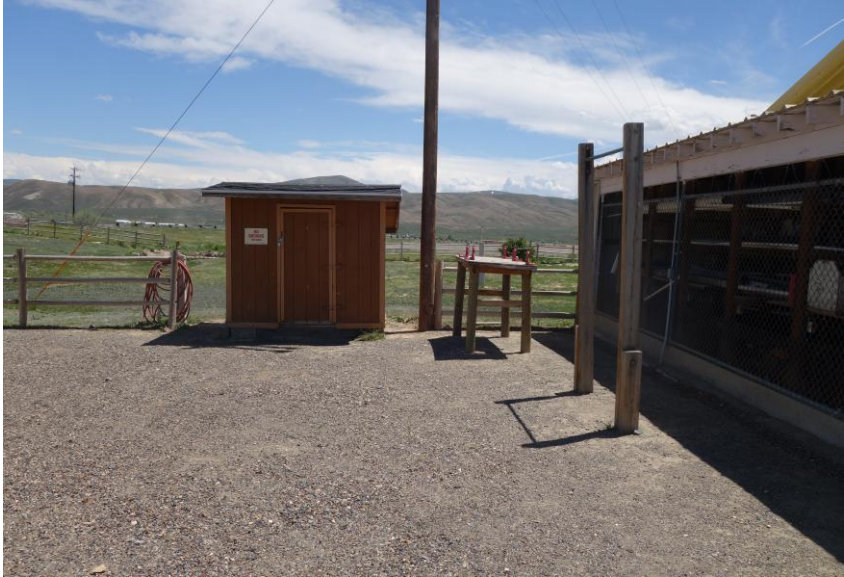
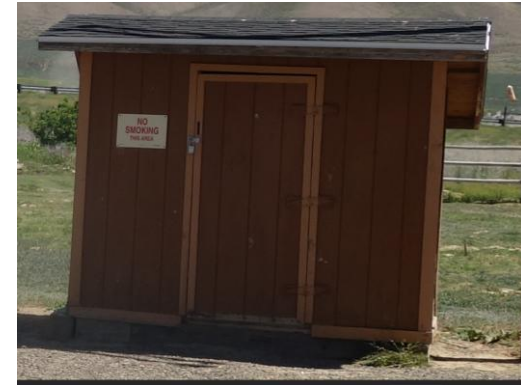
## REINSTATED BUILDING EXTERIOR - 11/17/2025 2151-EXT-1: EXTERIOR FINISHES

The exterior finishes were in good condition. It is important to maintain the finish, weather resistance and appearance of the building. This project recommends work to protect the exterior building envelope, other than the roof, including painting, staining, or other applied finishes, and caulking around windows, flashing, fixtures, and other penetrations to maintain the building in good, weather tight condition. It is recommended that this project be implemented in the next 6 - 8 years and is recommended on a cyclical basis based on environmental conditions.

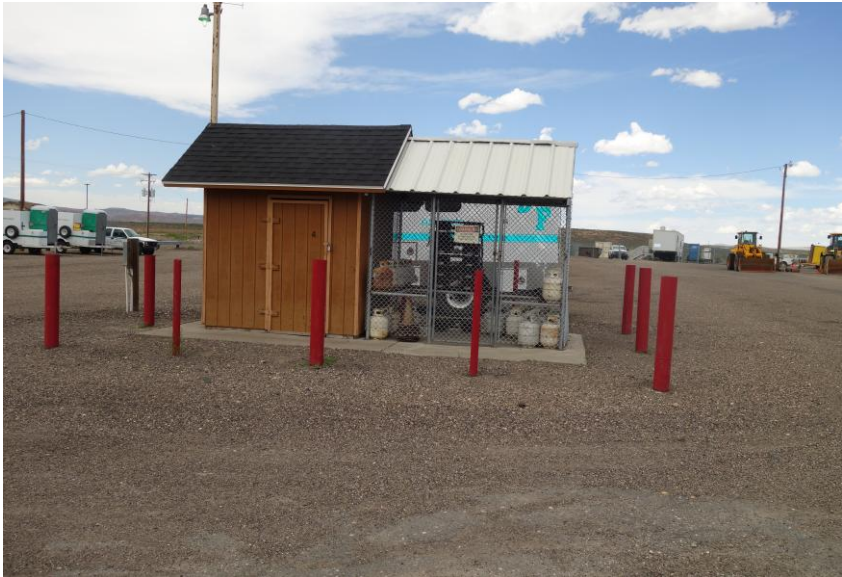
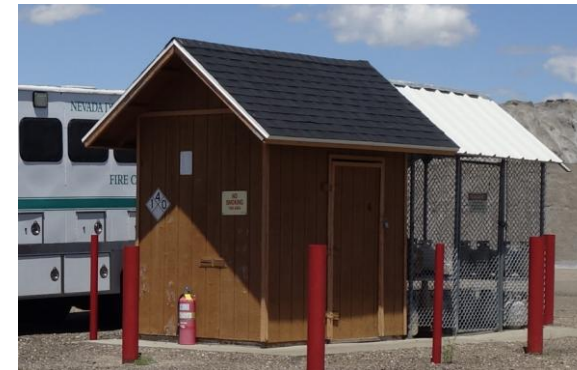
### REINSTATED BUILDING EXTERIOR - 11/17/2025 2152-EXT-1: EXTERIOR FINISHES

The exterior finishes were in good condition. It is important to maintain the finish, weather resistance and appearance of the building. This project recommends work to protect the exterior building envelope, other than the roof, including painting, staining, or other applied finishes, and caulking around windows, flashing, fixtures, and other penetrations to maintain the building in good, weather tight condition. It is recommended that this project be implemented in the next 6 - 8 years and is recommended on a cyclical basis based on environmental conditions.

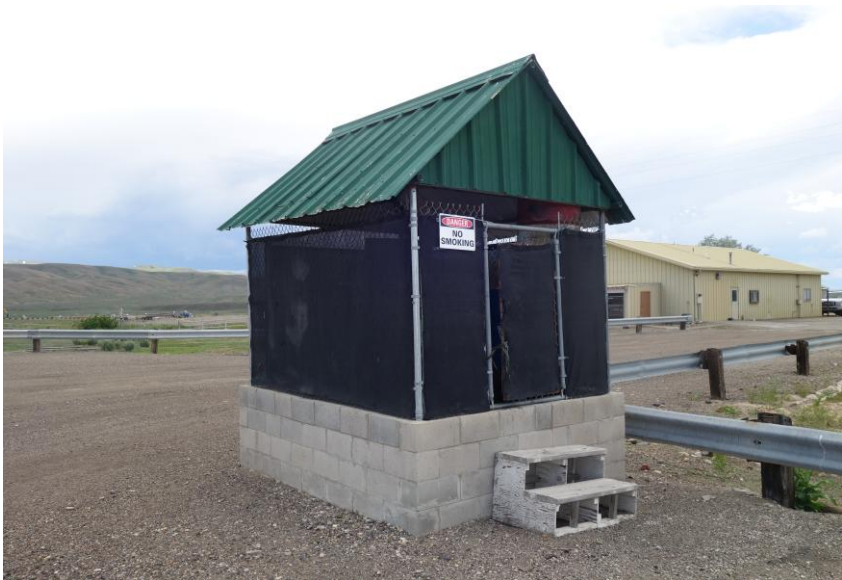
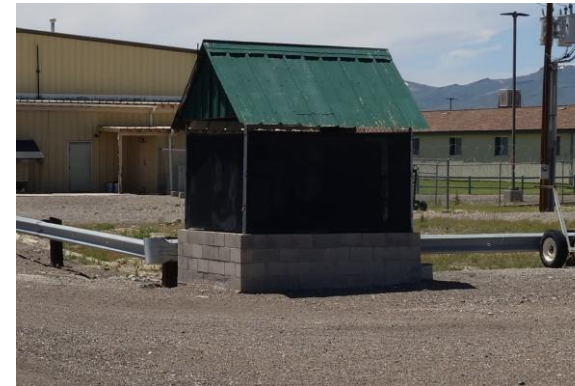
## NEW BUILDING EXTERIOR - 11/18/2025 4308-EXT-1: EXTERIOR FINISHES

The exterior finishes of the building are in good condition, and maintaining the building's finish, weather resistance, and appearance is essential. This project will fund improvements to protect the exterior envelope of the building, excluding the roof. The scope includes painting, staining, or sealing the exterior walls, along with caulking around windows, flashing, fixtures, and all other exterior penetrations. It is recommended that this work be completed within the next 7 - 9 years and scheduled on a recurring

maintenance cycle to preserve the structural integrity and visual condition of the facility.

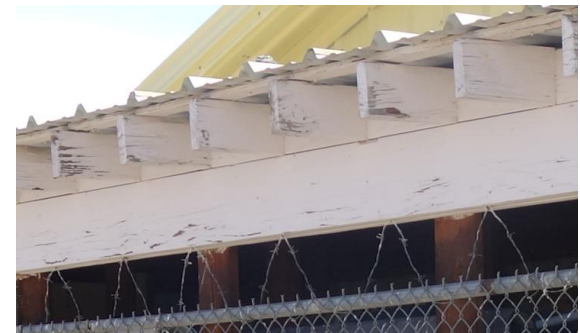
## REINSTATED BUILDING EXTERIOR - 11/14/2025 2148-EXT-1: EXTERIOR FINISHES

The exterior finishes were in fair condition. It is important to maintain the finish, weather resistance and appearance of the building. This project recommends work to protect the exterior building envelope, other than the roof, including painting, staining, or other applied finishes, and caulking around windows, flashing, fixtures, and other penetrations to maintain the building in good, weather tight condition. It is recommended that this project be implemented in the next 4 - 5 years and is recommended on a cyclical basis based on environmental conditions.

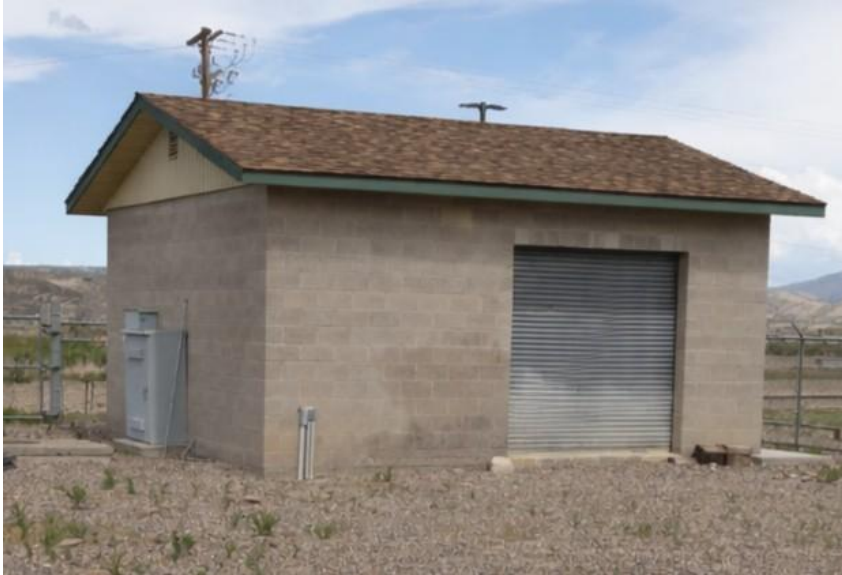
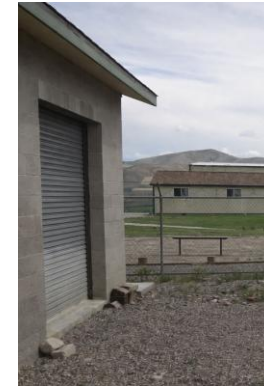
### REINSTATED BUILDING EXTERIOR - 11/14/2025 2144-EXT-1: EXTERIOR FINISHES

The exterior finishes were in good condition. It is important to maintain the finish, weather resistance and appearance of the building. This project recommends work to protect the exterior building envelope, other than the roof, including painting, staining, or other applied finishes, and caulking around windows, flashing, fixtures, and other penetrations to maintain the building in good, weather tight condition. It is recommended that this project be implemented in the next 7 - 9 years and is recommended on a cyclical basis based on environmental conditions.
